### OHIO TURNPIKE AND INFRASTRUCTURE COMMISSION

### ADDENDUM NO. 1 ISSUED: SEPTEMBER 1, 2023

### REQUEST FOR LETTERS OF INTEREST (LOIs) FOR PROFESSIONAL ENGINEERING SERVICES PROJECT NO. 71-23-09

## **PHYSICAL CONDITION REPORT** 2019 IN-DEPTH INSPECTION OF OHIO TURNPIKE BRIDGES OVER THE MAUMEE RIVER

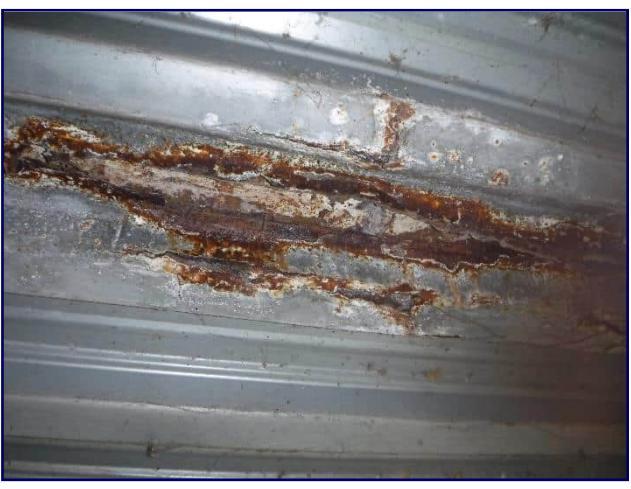
The floor is good condition overall with only localized advanced section loss at scattered stay-in-place (SIP) forms (Photo 1). While the SIP forms preclude direct inspection of the floor concrete, locations of seepage, rusting, and efflorescence on the forms indicate contamination and potential deterioration of the deck concrete. This deterioration was noted primarily in bays 6, 10 and 15. Isolated locations of minor SIP deformation were noted throughout the underside, likely from initial construction.

Photo 1: Typical localized section loss at SIP form.

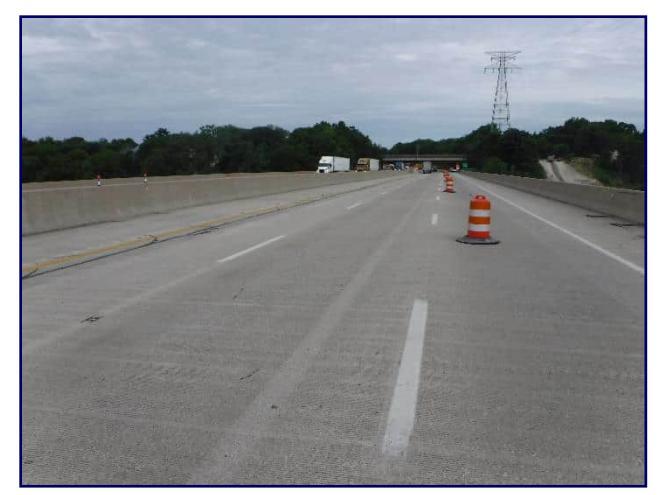
Photo 2: Typical top of deck condition.

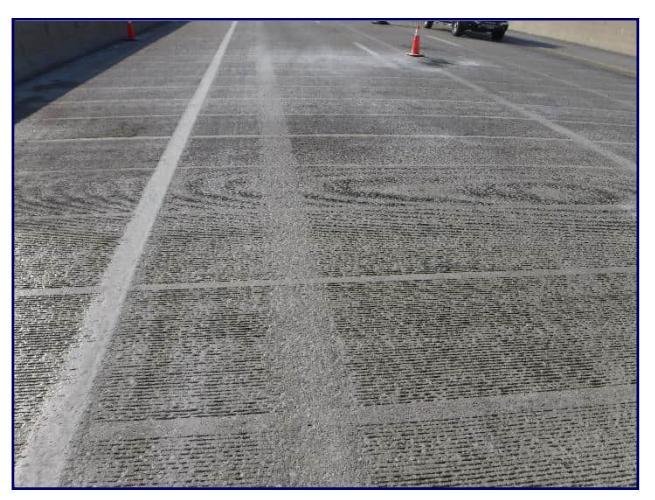
The wearing surface is in good condition with minor to moderate deficiencies noted. There is a considerable amount of spalled and patched concrete. Spall depths range from  $\frac{1}{2}$ " to 1" and are regularly patched with asphalt by Turnpike Maintenance (Photo 4). Patch conditions range from sound to deteriorating/spalling. Additionally the wearing surface exhibits notable wear, with the tinning completely worn away in wheel lines.

Photo 3: Tinning is worn in wheel lines.

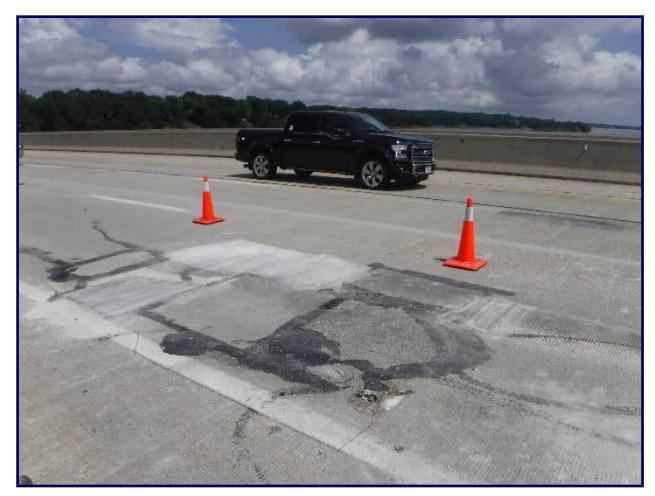
Photo 4: Typical deck patches. ITEM C11: RAILING [2.67 EB / 2.67 WB – FAIR – ODOT]

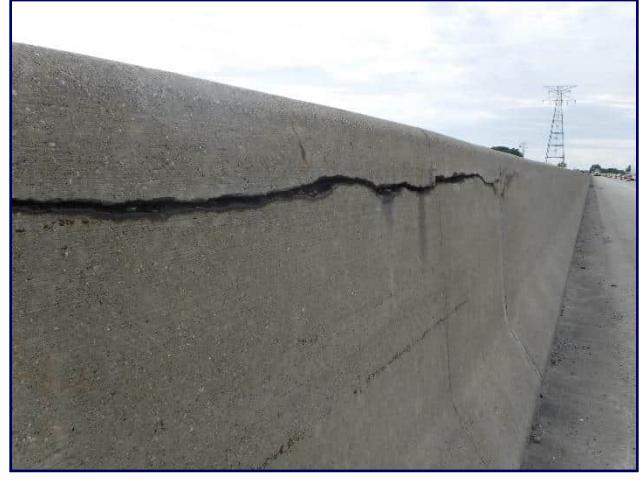
The outside and median parapets are in fair condition overall. All parapets exhibit full height vertical flexural cracking with light efflorescence spaced at 4 feet (Photo 6). There is widespread longitudinal cracking and delaminations in the top 6" of the parapets. The cracks are 10 to 20 feet in length on average and were saturated at the time of inspection (Photos 5 & 6). Areas of spalling noted in previous inspections have been repaired.

Photo 5: Typical longitudinal delamination along the interior of the parapets.

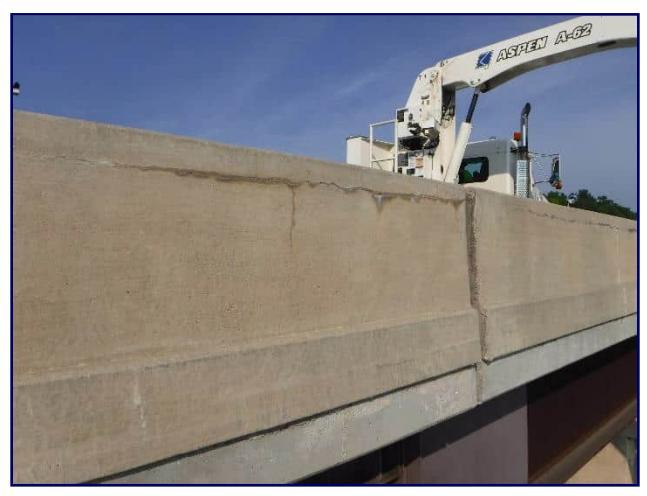
Photo 6: Typical longitudinal cracking along exterior of parapets.

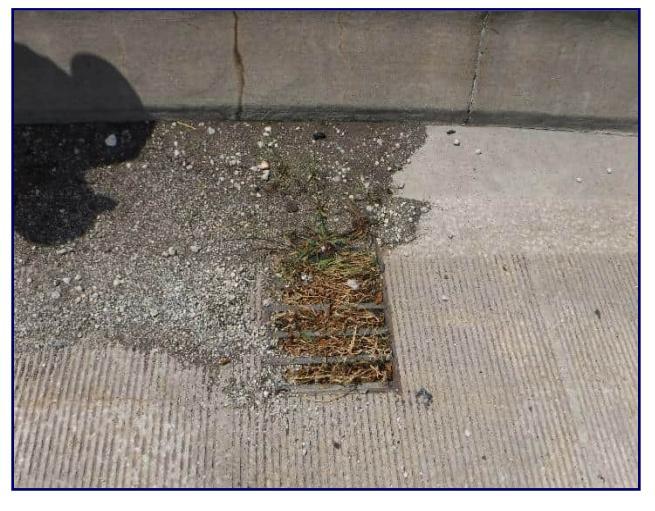
The bridge drainage is in good condition overall. Minor debris accumulation is typical at all scuppers and minor vegetation exists at two mid-span grates (Photo 7). All downspouts at each scupper were clear at the time of inspection with the exception of the middle right shoulder downspout on the eastbound deck which is clogged.

Photo 7: Clogged scupper, eastbound right shoulder.

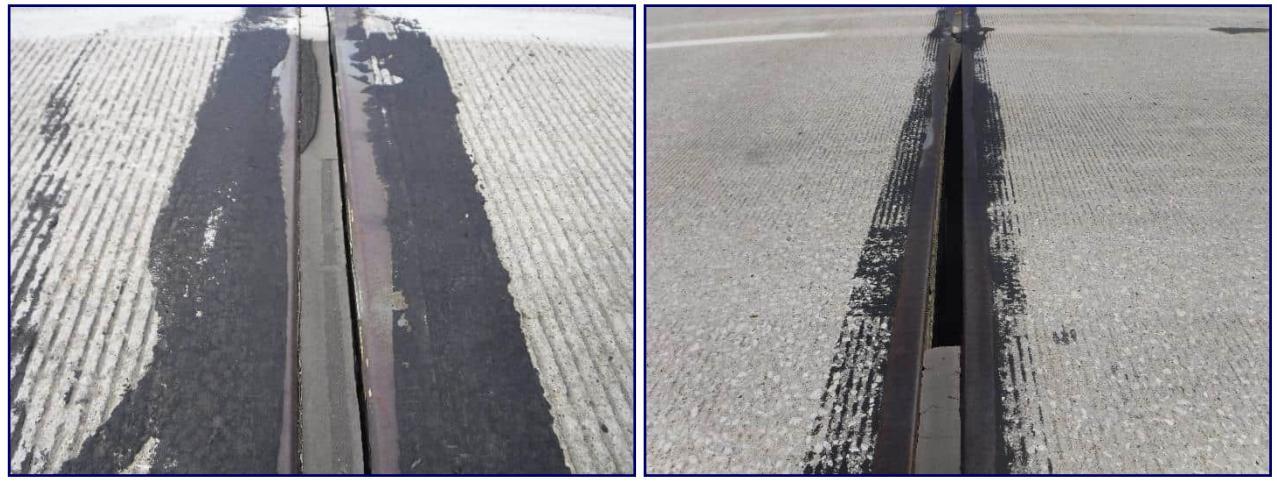
Photo 8: Typical intermediate expansion joint is completely debonded and failed.

The expansion joints are in poor condition overall. The glands are typically torn and/or separated from the joint extrusions and falling at each of the intermediate expansion joints (Photo 8). The gland failures are the full length of the joints and signs of leakage were noted throughout the superstructure below. The superstructure steel adjacent to the intermediate joints is actively corroding despite zone painting, a condition likely accelerated due to the chronic gland failures.

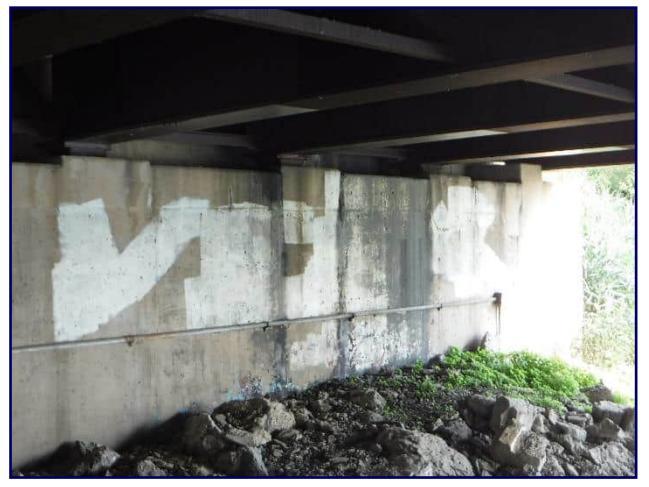
Photo 9: Typical abutment staining due to leaking joints.

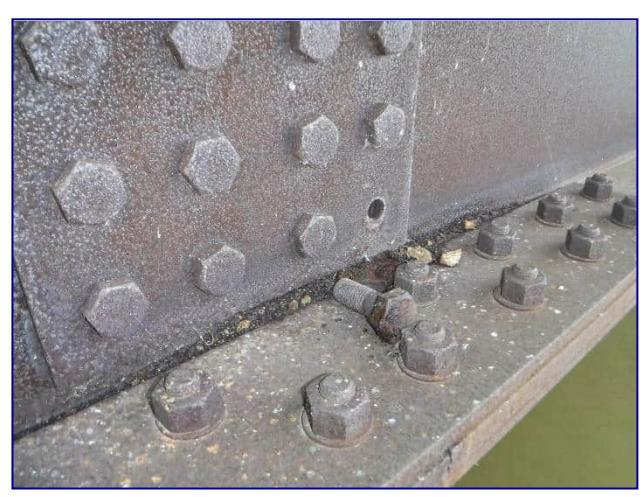
The ASTM A588 weathering steel girders are in good condition overall with minor to moderate deficiencies noted. Various splice bolt deficiencies were noted, including the following: one web splice bolt is missing at girder 16 in span 2 (Photo 10) with very slight deformation of the splice plate, two bottom flange bolts are backed off at girder 10 in span 9, two bottom flange bolts backed off at girder 11 in span 8 causing the flange splice plate to warp (Photo 11).

Photo 10: Missing splice bolt at girder 16 in span 2.

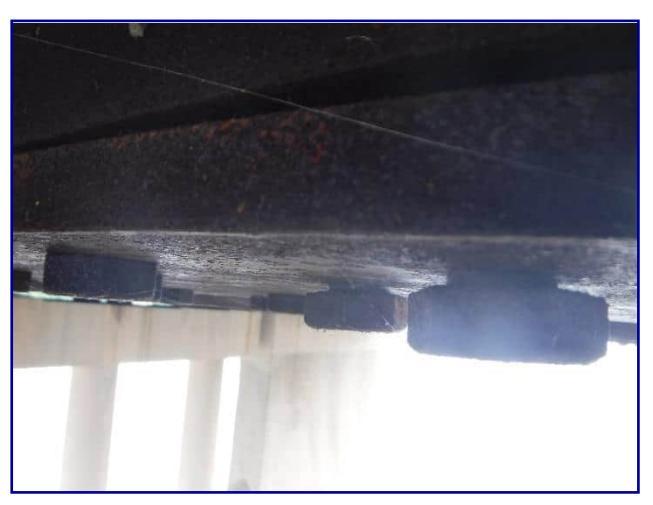
Photo 11: Backed off splice bolts and gap at girder 11 in span 8.

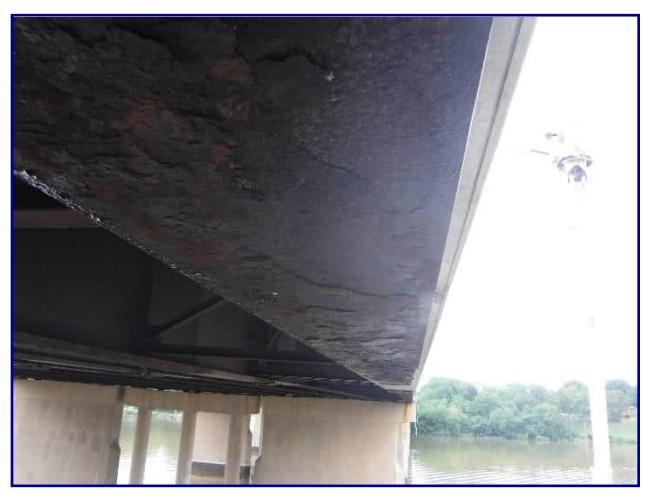
Photo 12: Typical flaking rust and section loss down grade from the expansion joints.

Several areas throughout the structure show signs of accelerated corrosion and non-protective oxides. The weathering steel down grade from the intermediate expansion joints typically exhibits large areas of flaking corrosion and section loss up to 1/16" (Photo 12). Likewise, a radius around each scupper cluster showed similar conditions. There are random areas throughout the structure that also have similar conditions, particularly in the fascia girders and near the abutments.

Since the joint glands have failed these moisture and chloride prone areas will continue deteriorating at a higher rate than the remainder of the superstructure.

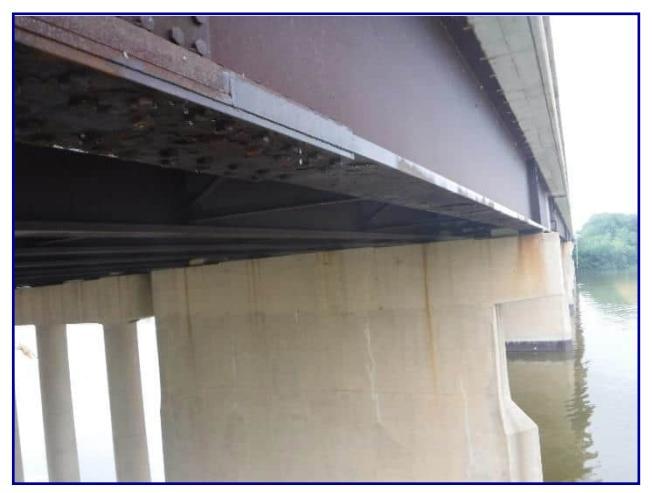
During the inspection, after rain, water was observed running down fascia girders and traveling along the bottom flange all the way to the next field splice (Photo 13). Section loss up to 1/16" was noted along the length.

Photo 13: Water running along fascia girder from expansion joint to splice plate.

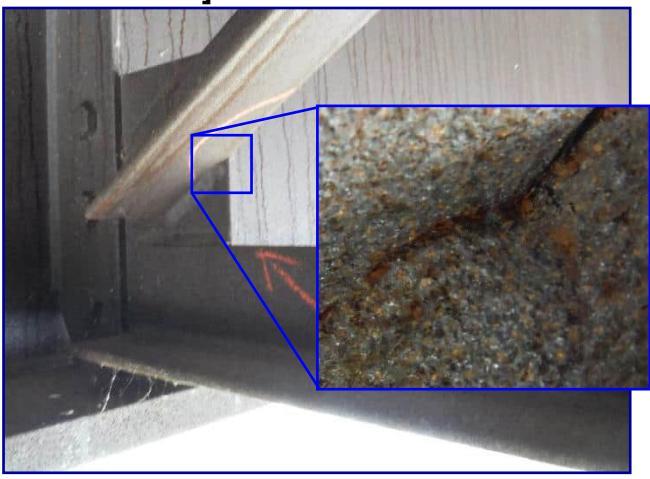
The previously noted crossframe members with signs of crack initiation along the diagonal to gusset weld toe are: span 8, bay 2, crossframe 5 at beam 3 (Photo 14, from previous inspection), span 8, bay 14, crossframe 4 at beam 14 (Photo 15, from previous inspection) and span 10, bay 4, crossframe 2 at beam 5 (Photo 16, from previous inspection). These areas were closely examined during the 2019 In-Depth inspection and no cracks could be positively Non-destructive verified. testing is recommended at these locations during the next In-Depth inspection to determine if these deficiencies actually exist.

Photo 14: Sign of crack initiation at crossframe diagonal to lower gusset weld (span 8, bay 2, crossframe 5 at beam 3).

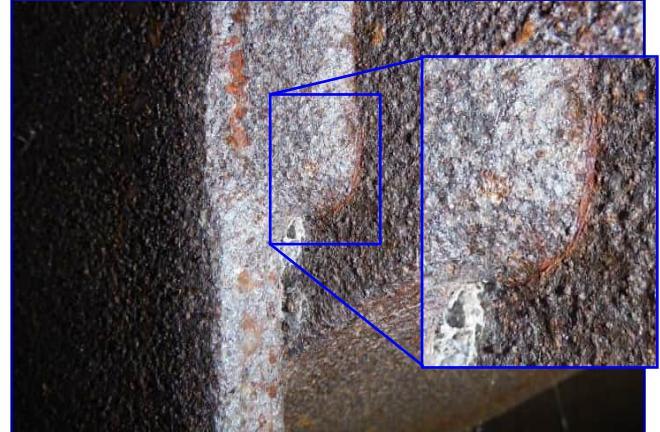
Photo 15: Sign of crack initiation at crossframe diagonal to lower gusset weld (span 8, bay 14, crossframe 4 at beam 14).

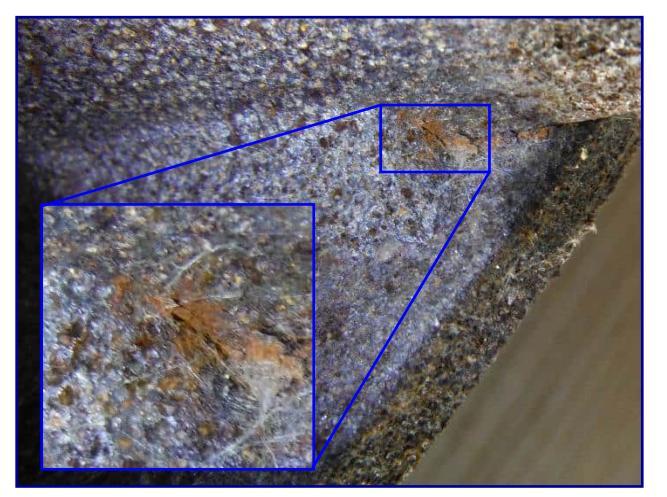
Photo 16: Sign of crack initiation at crossframe diagonal to lower gusset weld (span 10, bay 4, crossframe 2 at beam 5).

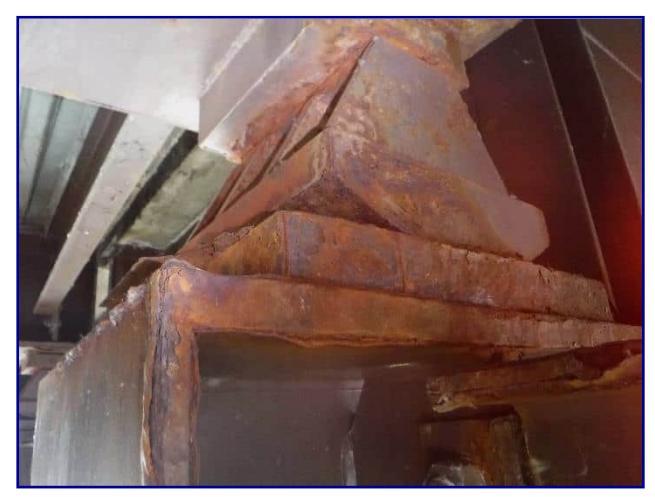
Photo 19: Surface and pack rust developing at bearings for intermediate expansion joints.

The rocker bearings at the intermediate expansion joints are generally in fair condition with no significant alignment issues; however pack rust is developing between the rockers and bearing plates throughout (Photos 19). Surface rust is forming on the bearing components at each joint. As discussed previously, joint membrane failures have allowed water and deicing agents to infiltrate freely and accelerate the condition.

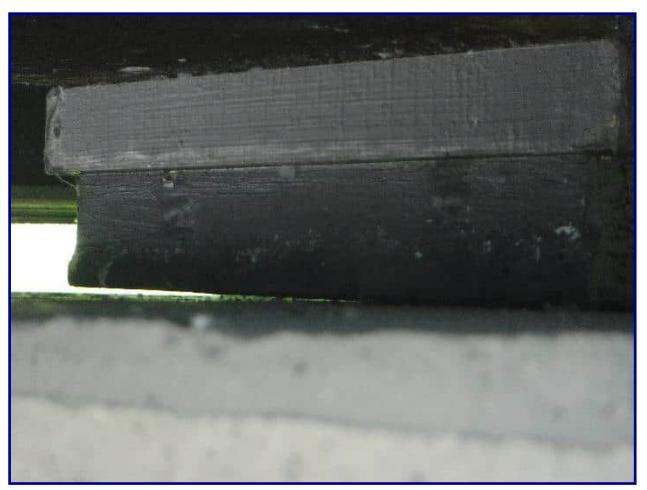
The bearing devices are in good condition overall with some minor deficiencies noted. At pier 10, the elastomeric pads at bearings 10 and 14-16 were found to not be in full contact with the seat with gaps up 1/4" to 3/8" at the northwest corners (Photo 17). This condition has been reported during past inspection cycles and does not appear to have changed significantly.

Photo 17: Typical bearing not in contact with seat.

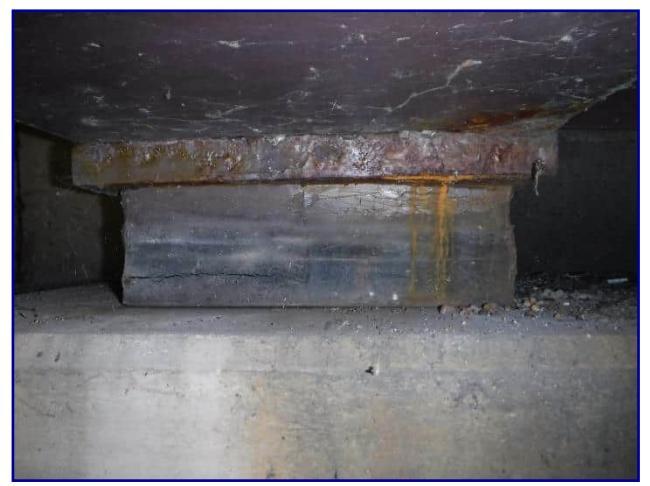
Minor to moderate bulging was noted at the abutment elastomeric pads. Bearing 2 at the west abutment is bulging up to 1" on all faces. The abutment bearing plates are typically developing surface rust, particularly bearings 2 through 4 at the west abutment. Isolated elastomeric pads at the pier bearings exhibit minor bulging and peeling up along the edges. At the east abutment, bearing 2 is bulging up to 1" and the elastomer is horizontally cracked (Photo 18).

Photo 18: Bulging approximately 1" and torn along the face of bearing 2, west abutment.

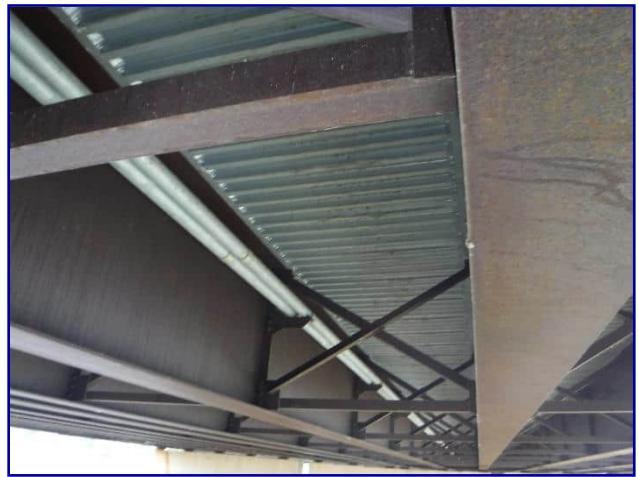
The protective coating system is in good condition overall. The majority of the weathering steel surfaces have a welldeveloped patina that is tightly adhered (Photo 20). The coloration is typically a deep brown, with sporadic yellow/orange where mill scale or weld byproducts have recently yielded to rust development.

Photo 20: Typically, weathering steel has a well developed patina.

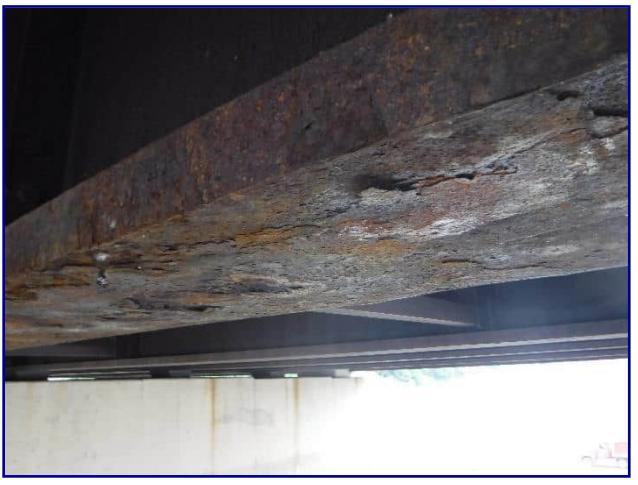
Photo 21: Flaking rust along the bottom of the bottom flange.

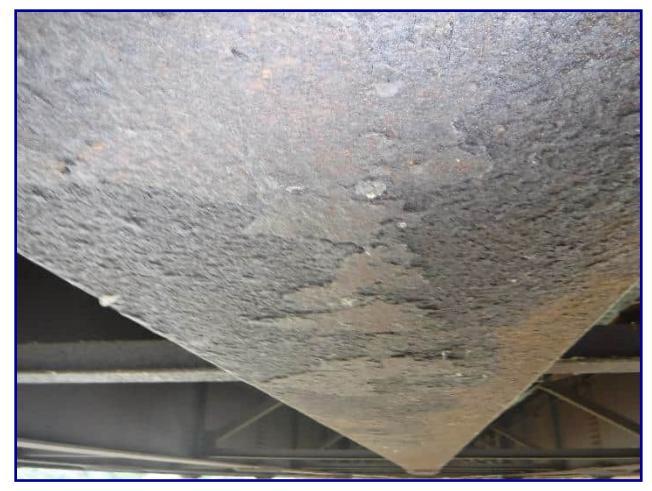
Photo 22: Flaking rust and pitting along the bottom of the bottom flange.

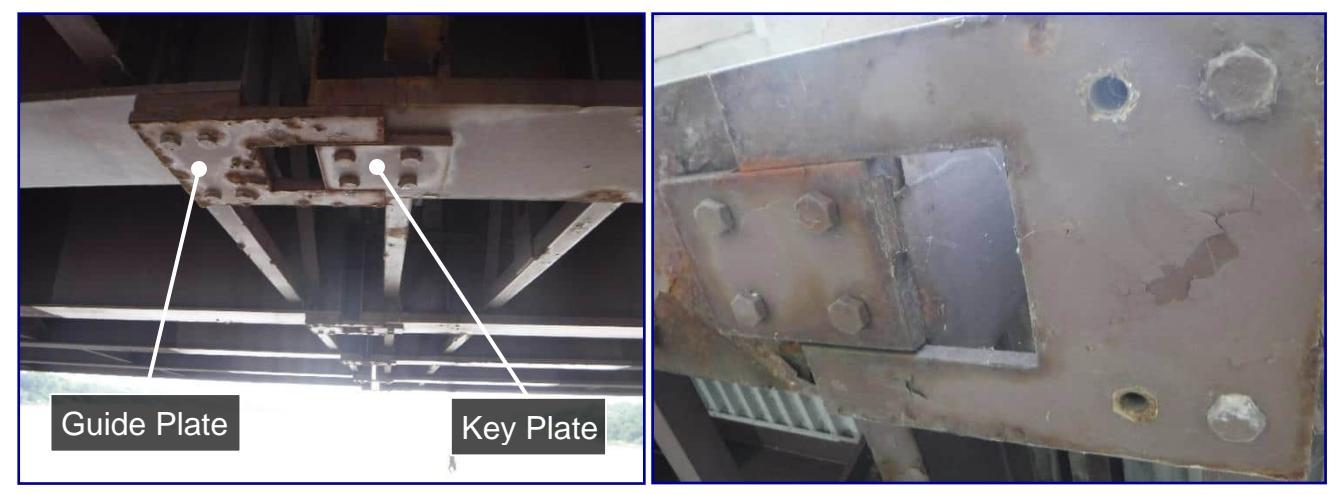
Photo 23: Typical hinge guide assembly detail and Photo 24: Span 7, girder 1 guide assembly with two missing. nomenclature.

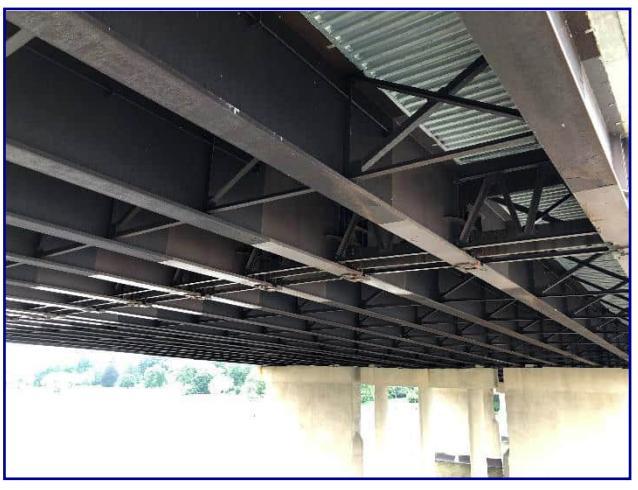
The hinges are located in spans 4 and 7 and are in fair condition overall. The deficiencies controlling the rating are the development of pack rust at rockers and isolated missing guide plate bolts. At the span 7 joint, the girder 1 guide plate is missing two bolts and one of the two remaining bolts is missing a nut (Photo 24). A 1/4" gap is present between the spacer plate and the flange. A similar gap has formed other isolated guide plates throughout however, all bolts were intact at the time of inspection. Other guide assemblies throughout the structure are producing abrasion dust and have minor wear and misalignments at the plate interfaces as a result of normal movement under live load.

Photo 25: General view of span 4 hinges.

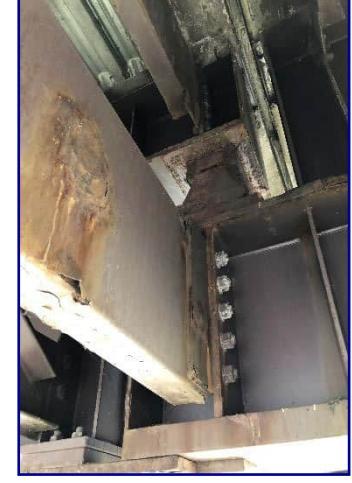
Photo 26: General condition of span 7 hinges.

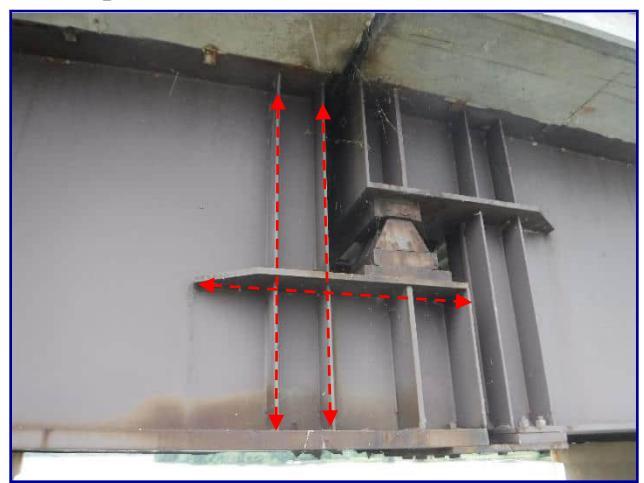
The Category E/E' fatigue prone details are in condition overall. Three good welded connections at each hinge seat constitute Category E fatigue prone details (Photo 27): two vertically welded stiffeners and one longitudinally welded seat plate. The welded connections were inspected at arm's reach at each intermediate joint and no sign of fatigue distress was observed. The paint at the beam ends is beginning to deteriorate but does not currently impact the detail performance (Photo 28). However, these areas should be maintained in order to facilitate detailed inspections in the future.

Photo 27: Category E/E' fatigue prone details at the hinges with tension regions highlighted in the lower seat. Upper seat reactions are reciprocal.

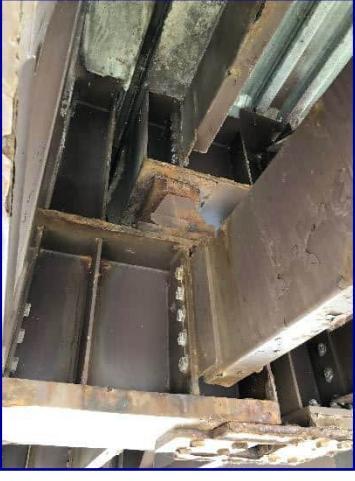
Photo 28: Lower seat plate and vertical stiffener welds with active rusting.

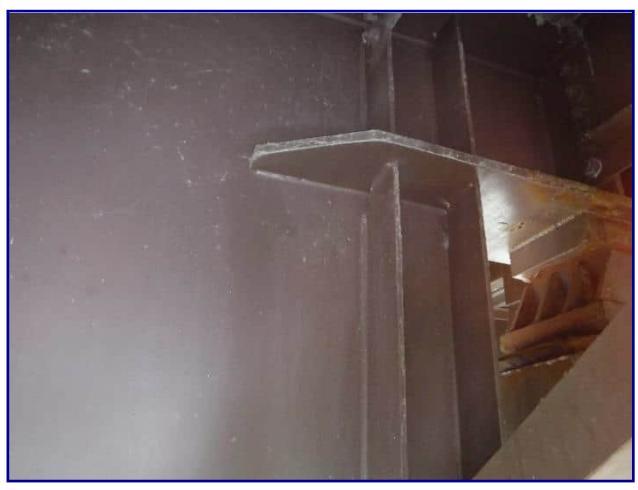
Photo 29: Typical upper seat plate and vertical stiffener welds.

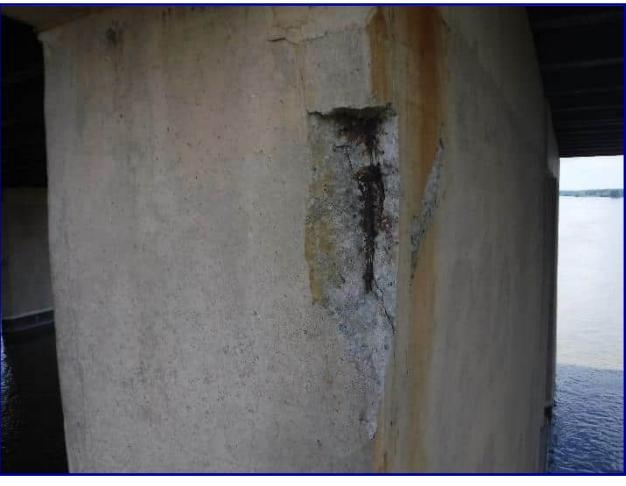
The pier walls are in good condition overall. Small spalls and delaminated areas were noted at isolated areas. The most significant of these is at pier 8 where a spall and adjacent 5' tall by 4' wide delaminated area is located on the southeast corner of the south pier wall near the cap (Photo 30). Reinforcement is exposed with slight section loss at the time of inspection. There is also a large 8 SF delamination on the west face of eastbound pier 1.

Photo 30: Spall and delamination with exposed rebar on pier 8.

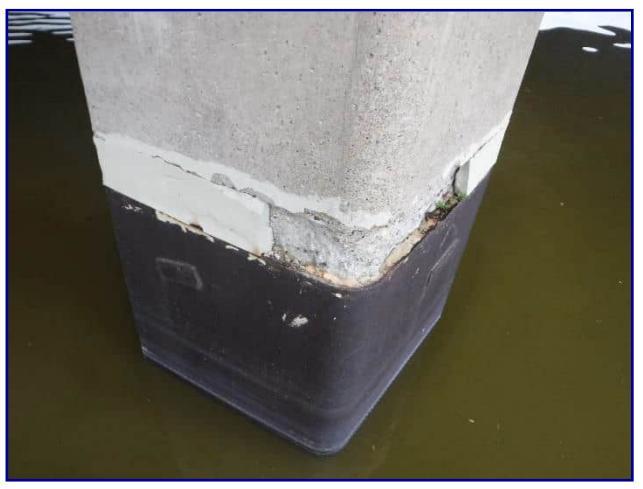
Cracking, delaminations, and spalls are occurring in the grout patches just above the steel encasements (Photo 31).

Photo 31: Spalling and delaminations typical in grout patches along bases of piers.

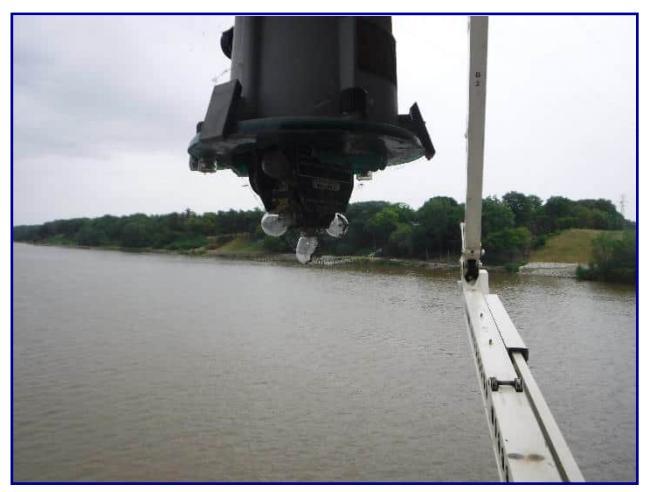
The navigation lights are in good condition overall, however the green light casing on the north side of the structure is missing (Photo 36). The navigation lights were not illuminated at the time of the inspection so it could not be determined if any bulbs are not functioning.

Photo 36: Broken navigation light casing on north side of structure.

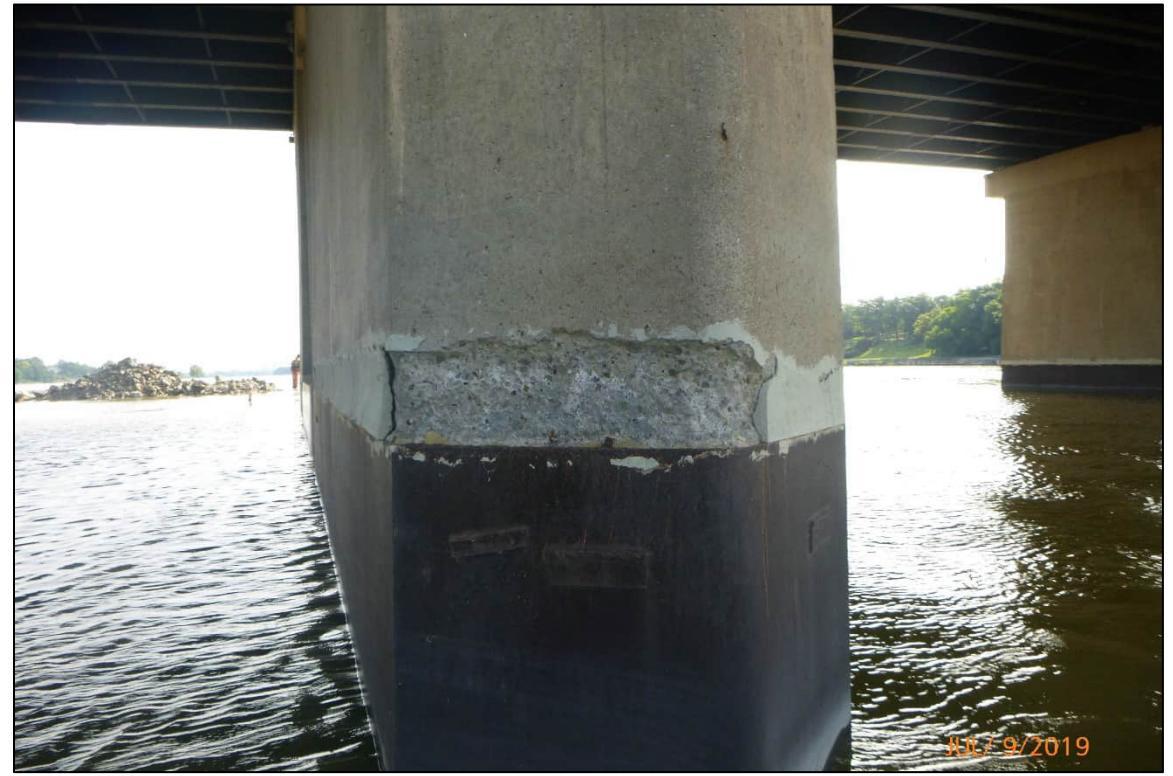
Photograph No. 27: View of the Typical Spalling of the Grout Repair at the Upstream Nose, Looking North.
