OHIO TURNPIKE AND INFRASTRUCTURE COMMISSION 62nd ANNUAL CONSULTING ENGINEER INSPECTION REPORT

Sixty Second Annual Consulting Engineer Inspection Report

2017 Annual Inspection Report

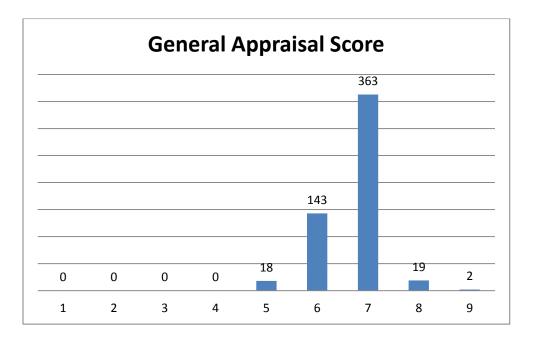
Figure 2.3.1 – Graph showing distribution of overall NBIS Condition Ratings for bridges maintained by the OTIC. NBIS Scoring criteria based on 1-9 evaluation with 1 being Imminent Failure and 9 being Excellent. Ratings of 5 or greater indicate structural elements may or may not show deterioration but remain sound with no significant affects to the main load path. For additional information see ODOT MBI 2014 Table 34.

to National Bridge Inspection Standards (NBIS). Per ODOT and OTIC policy the total number of bridges maintained by OTIC is 544. Out of a total of 544 bridges, only 3.3% of the structures (18 total) rate below Satisfactory Condition (Figure 2.3.1) and the majority of deficiencies at these structures is related to substructure (piers and abutments) concrete deterioration. Of the substructure deficiencies, the most downgraded element impacting the overall structure rating was found to be the piers. The piers rating below Satisfactory do not currently pose a safety hazard to the public; however, continued deterioration has the potential to increase maintenance and repair costs as well as decrease the overall service life of the structures. Rehabilitation should be performed at these structures in the near future and the deficient elements should be monitored closely until repairs can be made. Figure 2.3.2 shows the changes in these scores by percentage of inventory over time.

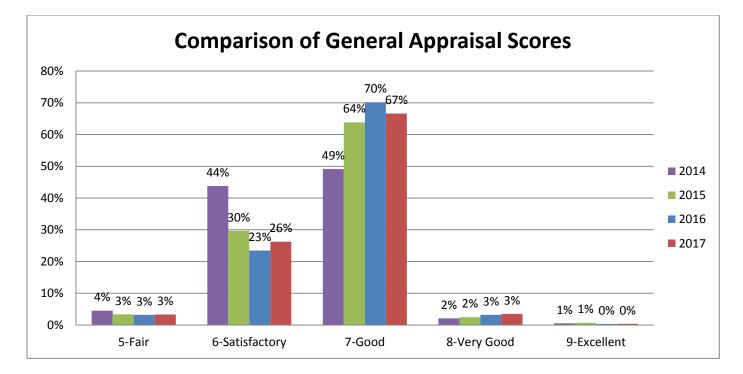
Figure 2.3.2 – Graph showing distribution of General Appraisal ratings for bridges maintained by the OTIC as viewed on the SMS inspection form from 2014-2017.

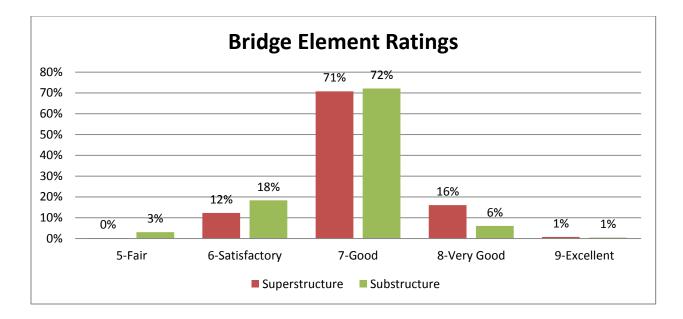
Figure 2.3.3 – Graph showing distribution of Superstructure and Substructure summary ratings for bridges maintained by the OTIC as viewed on the SMS inspection form.

The "General Appraisal and Operational Status" rating given to each structure describes its overall condition. Based on a scale of 1 thru 9, this rating is determined, in essence, by the Substructure or Superstructure (beams) conditions. Review of the summary ratings produced from the findings of the 2017 bridge safety inspections shows that substructure elements remain the predominant controlling factor in the overall General Appraisal ratings. Ratings continue to increase in 2017 compared to 2014 through 2016 due to the changes in FHWA element level scoring criteria as well as a significant number of focused rehabilitations. 2014 is used as the current baseline for comparison as this was the first year Element Level Scoring Criteria was utilized in the bridge safety inspections. Element level scoring criteria assigns the score based on percentage deficient rather than a score based on the lowest deficient item controlling the For example, under the previous scoring system, a bridge where 90% of the entire score. superstructure is good and 5 % is satisfactory and 5 % is fair, then the entire structure would be rated as fair while under the new element level scoring the superstructure would be rated as good. Figure 2.3.3 shows that only 3% of OTIC substructure summaries (13 structures) receive below a satisfactory rating (NBIS-6), while 0.2% (1 structure) of the superstructure summaries receives a rating below satisfactory (NBIS-6). Figure 2.3.4 and Figure 2.3.5 show the changes over time between superstructure and substructure ratings for the last four years where element level scoring was utilized.

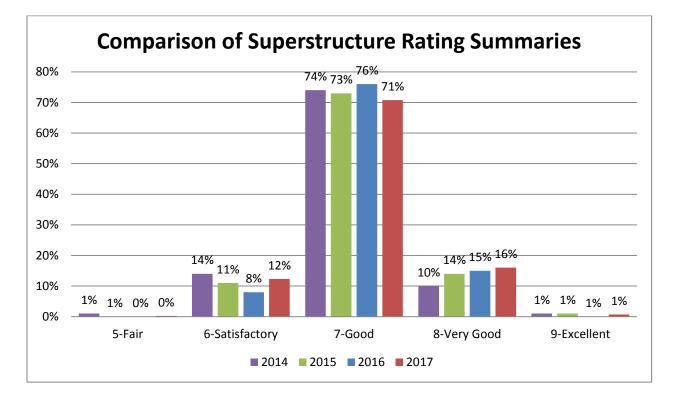
Figure 2.3.4 – Graph showing distribution of Superstructure summary ratings for bridges maintained by the OTIC as viewed on the SMS inspection form from 2014-2017.

Superstructure ratings for steel structures (the predominant type of superstructure on the Turnpike) are typically controlled by the amount of steel section loss and cracking in secondary diaphragm members and connection plates. The condition of the steel structures is generally good (NBIS-7) with regard to section loss. This can in large part be attributed to the OTIC on-going bridge painting program.

Some structures were noted to have diaphragm and weld cracks forming as well as loosening connectors, and the OTIC should consider a long-term maintenance and repair plan to mitigate these effects and extend the useable life of the structures. As of 2017 this is occurring in approximately 50 structures and while not being a safety issue, it should continue to be closely monitored. Additionally, as a part of the next inspection cycle, the OTIC should consider

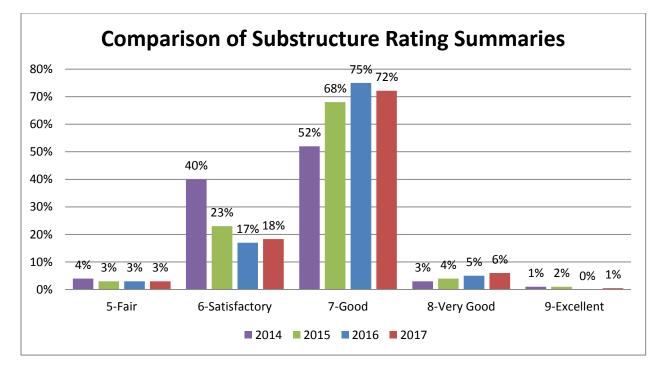
Figure 2.3.5 – Graph showing distribution of Substructure summary ratings for bridges maintained by the OTIC as viewed on the SMS inspection form from 2014-2017.

In general, a below satisfactory summary rating does not indicate a condition that is unsafe for either of these elements. However, based on the distribution of ratings, the OTIC should consider developing a substructure preventative maintenance and repair plan aimed to extend the usable life of these critical infrastructure elements.

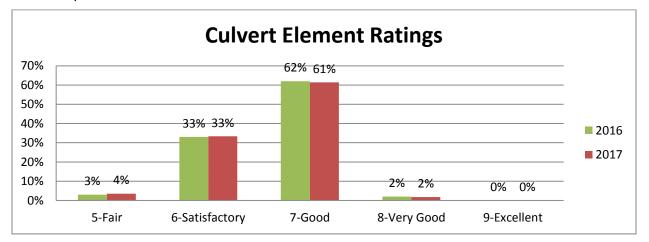
Structures having a clear span of 10 feet or greater are inspected and reported as bridges per Ohio Revised Code Section 5501.74 however when spans are less than 20 feet they do not meet the Federal definition of a bridge. There are currently 109 structures owned and maintained by the OTIC that fall into this category out of the 544 bridges noted in section 2.3. The majority of these culverts are cast-in-place reinforced concrete box shapes with single or multiple cells. The most common deficiencies include deteriorated headwalls and wingwalls and obstruction and scour of the waterways. Three culverts with a span over 10 feet are in Poor Condition. These culverts do not currently pose a safety hazard to the traveling public, but if left unrepaired could lead to costly erosion and/or settlement damage along the Turnpike. Figure 2.4.1 shows a summary of the element level ratings for culverts maintained by the OTIC for both 2016 and 2017. Due to changes in ODOT's SMS data reporting this information was not readily available prior to 2016.

Figure 2.4.1 – Graph showing element ratings for culverts maintained by the OTIC as viewed on the SMS inspection form for both 2016 and 2017
