**OHIO TURNPIKE AND  
INFRASTRUCTURE COMMISSION  
66<sup>th</sup> ANNUAL  
CONSULTING ENGINEER INSPECTION REPORT**

**Sixty-Sixth Annual  
Consulting Engineer  
Inspection Report**

The Ohio Turnpike and Infrastructure Commission  
682 Prospect Street  
Berea, Ohio 44017

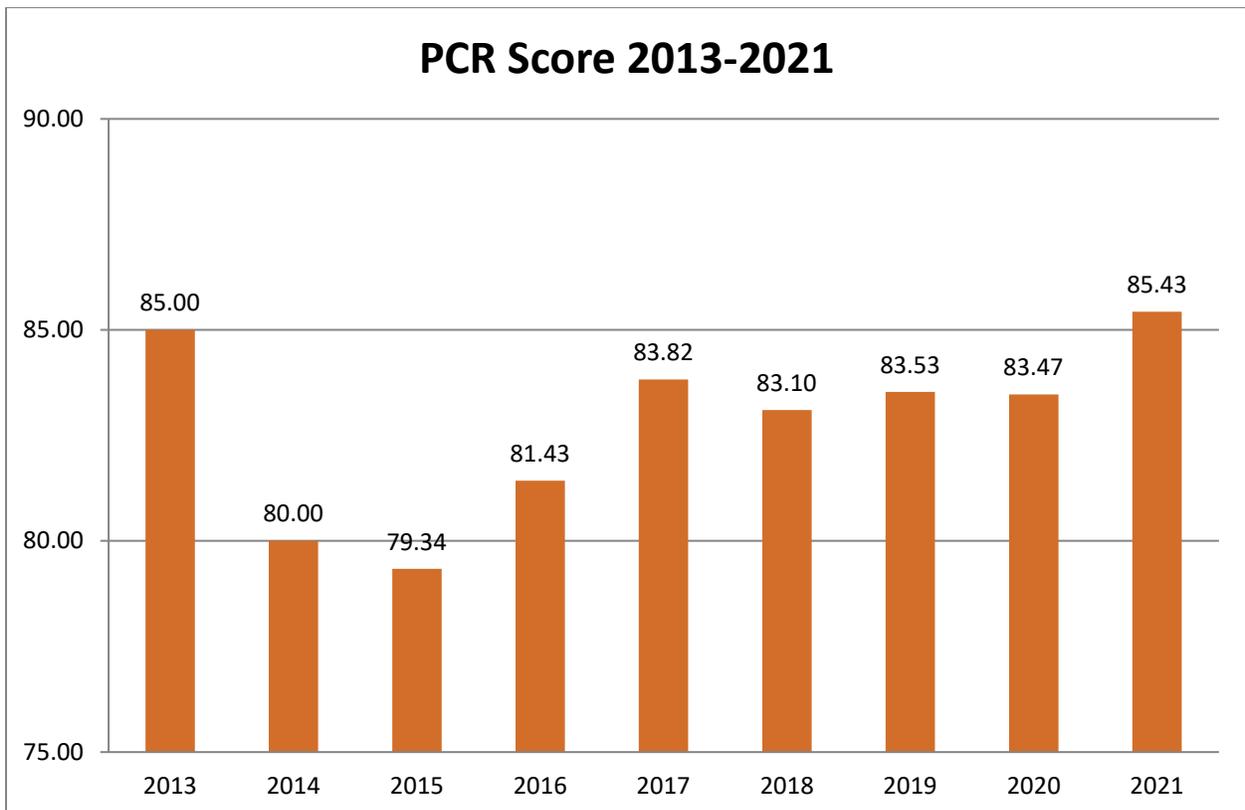
Figure 2.1.1 – Graph showing distribution of Pavement Condition Ratings over time (PCR scoring criteria from ODOT)

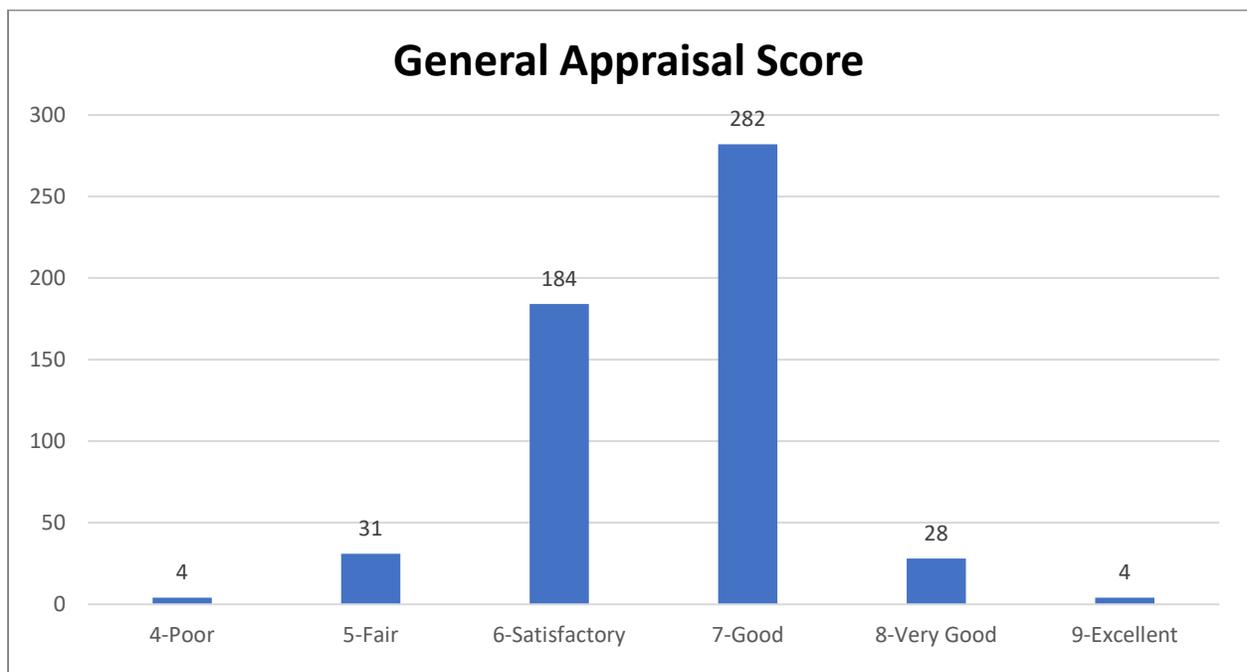
Based on the bridge condition inspections performed in 2021, the large majority of bridges maintained by the OTIC are in Satisfactory to Excellent Condition (NBIS Scores 6-9) according to National Bridge Inspection Standards (NBIS). Per ODOT and OTIC policy the total number of bridges maintained by OTIC is 533 (419 bridges plus 114 culverts classified as bridges). Out of a total of 533 bridges, only 6.6% of the structures (35 total, 30 bridges plus 5 culverts classified as bridges) rate below Satisfactory Condition (**Figure 2.3.1**) and the majority of deficiencies at these structures is related to substructure (piers and abutments) concrete deterioration. This number is up 0.8% from 2020. Of the substructure deficiencies, the most downgraded element impacting the overall structure rating was found to be the piers. The piers rating below Satisfactory do not currently pose a safety hazard to the public; however, continued deterioration has the potential to increase maintenance and repair costs as well as decrease the overall service life of the structures. Rehabilitation should be performed at these structures in the near future and the deficient elements should be monitored closely until repairs can be made. **Figure 2.3.2** shows the changes in these scores by percentage of inventory over time.

*Figure 2.3.1 – Graph showing distribution of overall NBIS Condition Ratings for bridges maintained by the OTIC. NBIS Scoring criteria based on 1-9 evaluation with 1 being Imminent Failure and 9 being Excellent. Ratings of 5 or greater indicate structural elements may or may not show deterioration but remain sound with no significant affects to the main load path. For additional information see ODOT MBI 2014 Table 34.*

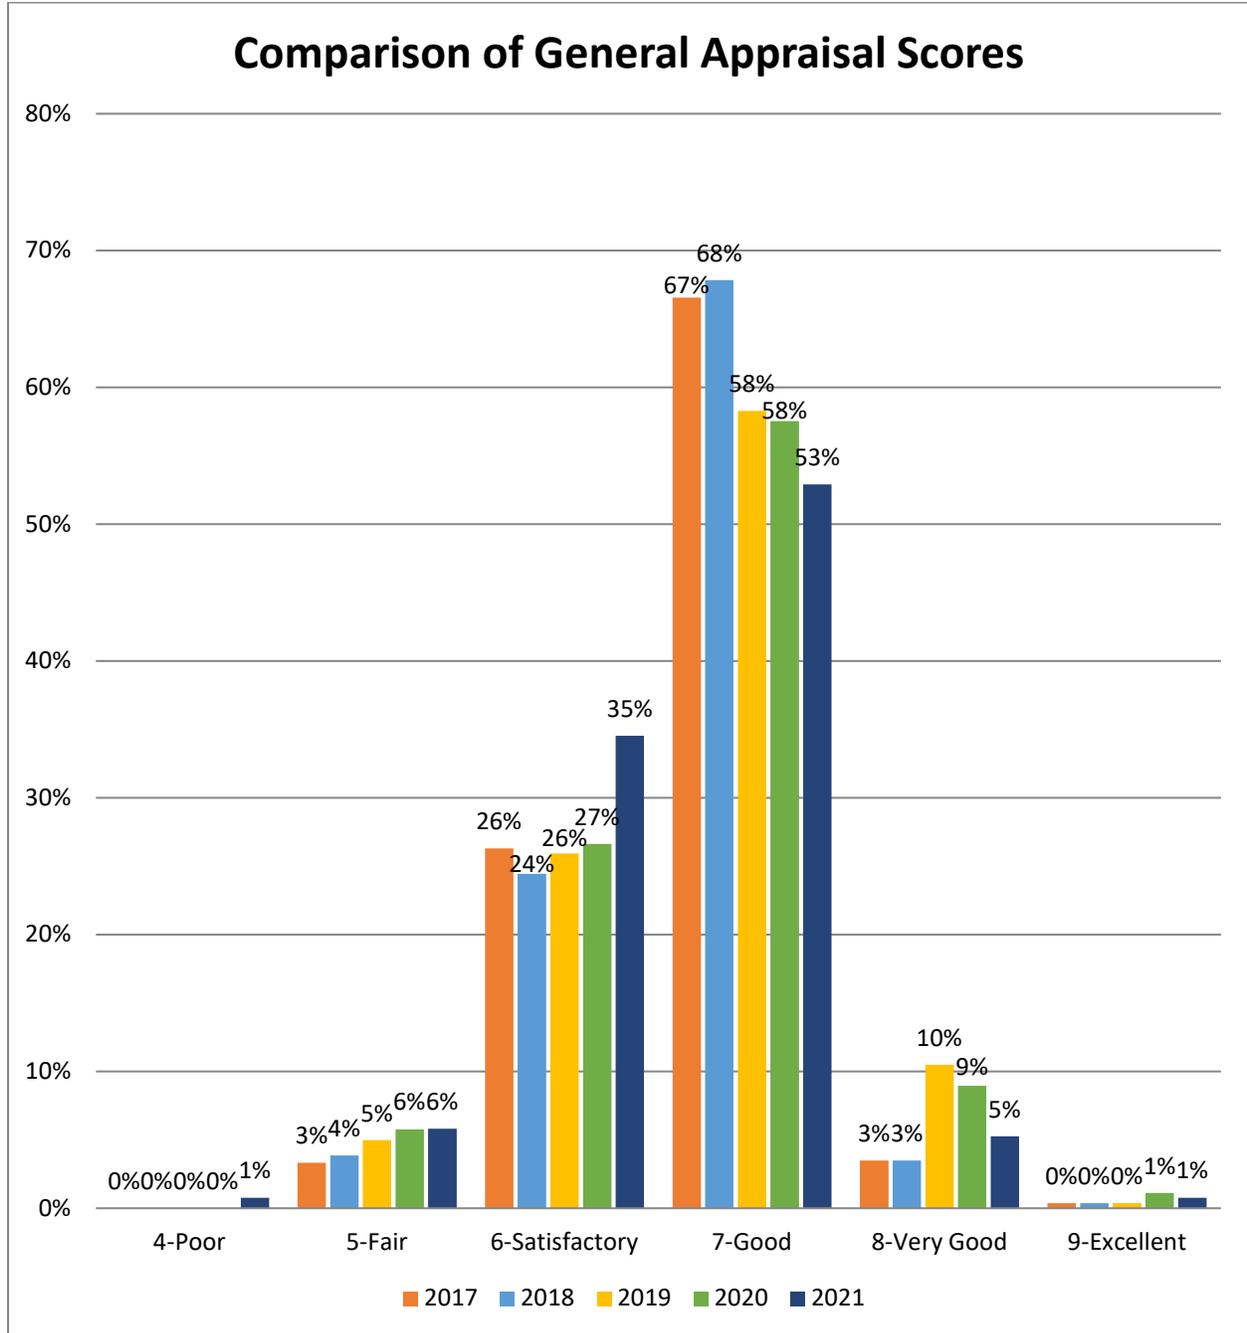
Figure 2.3.2 – Graph showing distribution of General Appraisal ratings for bridges maintained by the OTIC as viewed on the Assetwise inspection form from 2017-2021. (Note due to rounding and for clarity total may not equal 100% in some years)

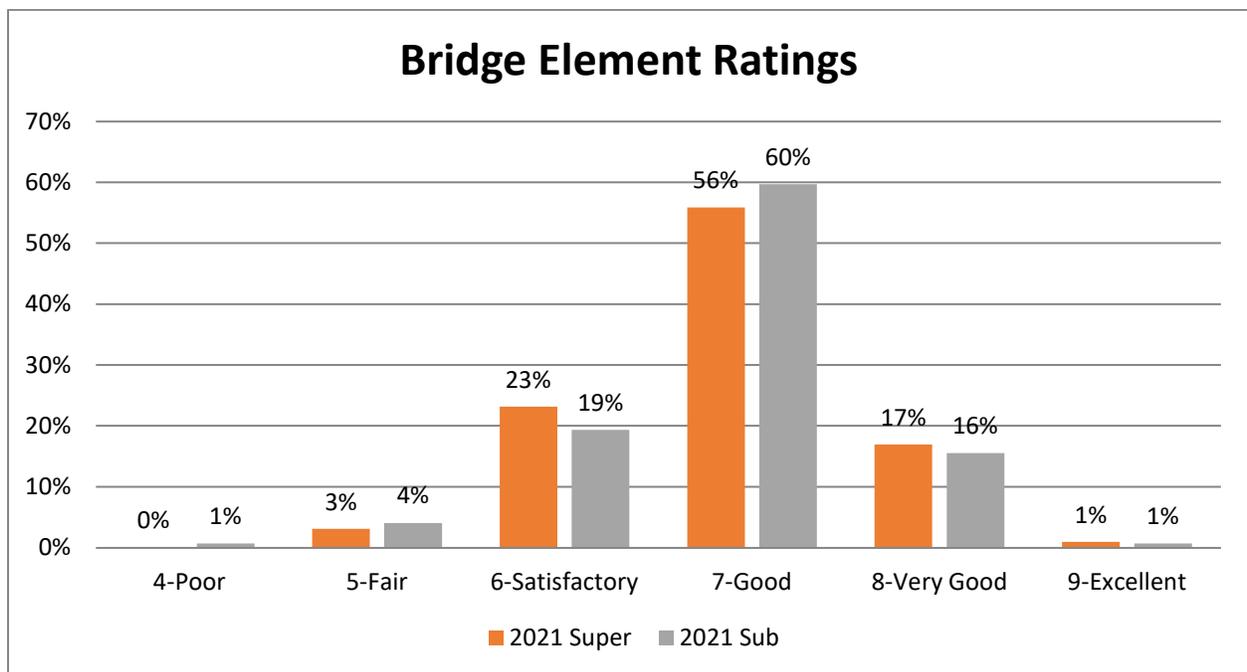
the predominant controlling factor in the overall General Appraisal ratings. 2014 was the first year Element Level Scoring Criteria was utilized in the bridge safety inspections. Element level scoring criteria assigns the score based on percentage deficient rather than a score based on the lowest deficient item controlling the entire score. For example, under the previous scoring system, a bridge where 90% of the superstructure is good, 5% is satisfactory, and 5% is fair; the entire structure would be rated as fair. Under the new element level scoring the superstructure would be rated as good. **Figure 2.3.3** shows that 5% of OTIC substructure summaries (20 structures) receive below a satisfactory rating (NBIS-6), while 3% (13 structures) of the superstructure summaries receives a rating below satisfactory (NBIS-6). **Figure 2.3.4 and Figure 2.3.5** show the changes over time between superstructure and substructure ratings for the last five (5) years where element level scoring was utilized.

*Figure 2.3.3 – Graph showing distribution of Superstructure and Substructure summary ratings for bridges maintained by the OTIC as viewed on the Assetwise inspection form. (Note due to rounding for clarity total may not equal 100%)*

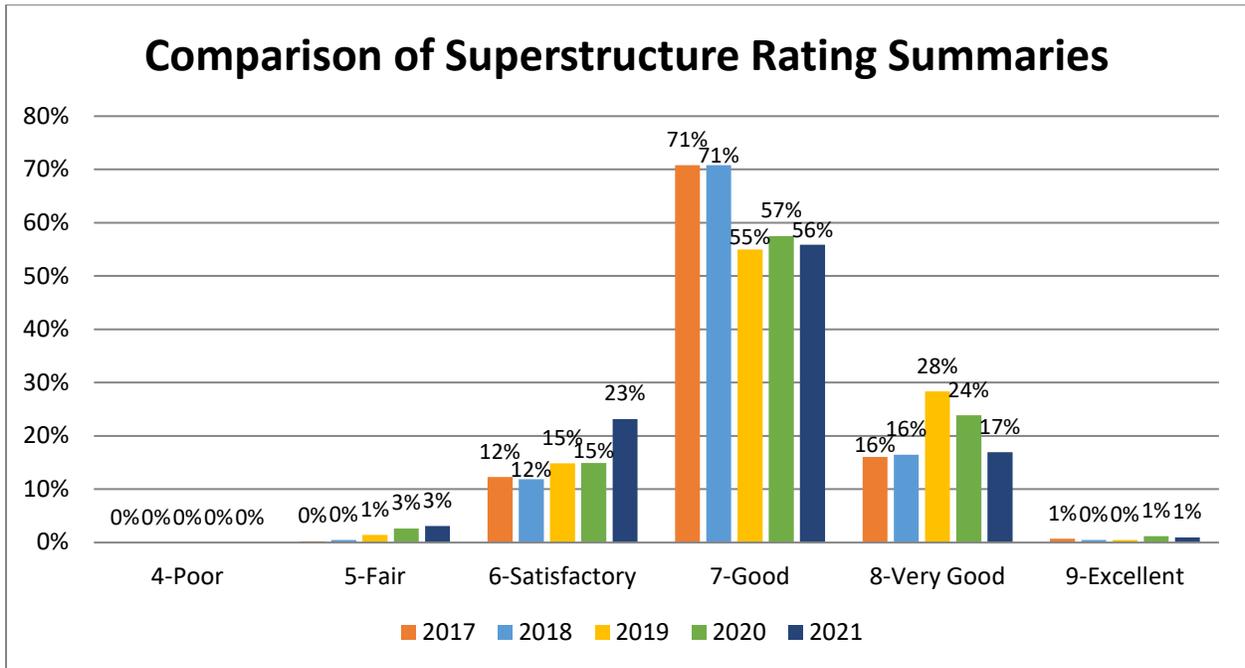
Figure 2.3.4 – Graph showing distribution of Superstructure summary ratings for bridges maintained by the OTIC as viewed on the Assetwise inspection form from 2017-2021. (Note due to rounding for clarity total may not equal 100% in some years)

Superstructure ratings for steel structures (the predominant type of superstructure on the Turnpike) are typically controlled by the amount of steel section loss and cracking in secondary diaphragm members and connection plates. The condition of the steel structures is generally good (NBIS-7) with regard to section loss. This can in large part be attributed to the OTIC on-going bridge painting program.

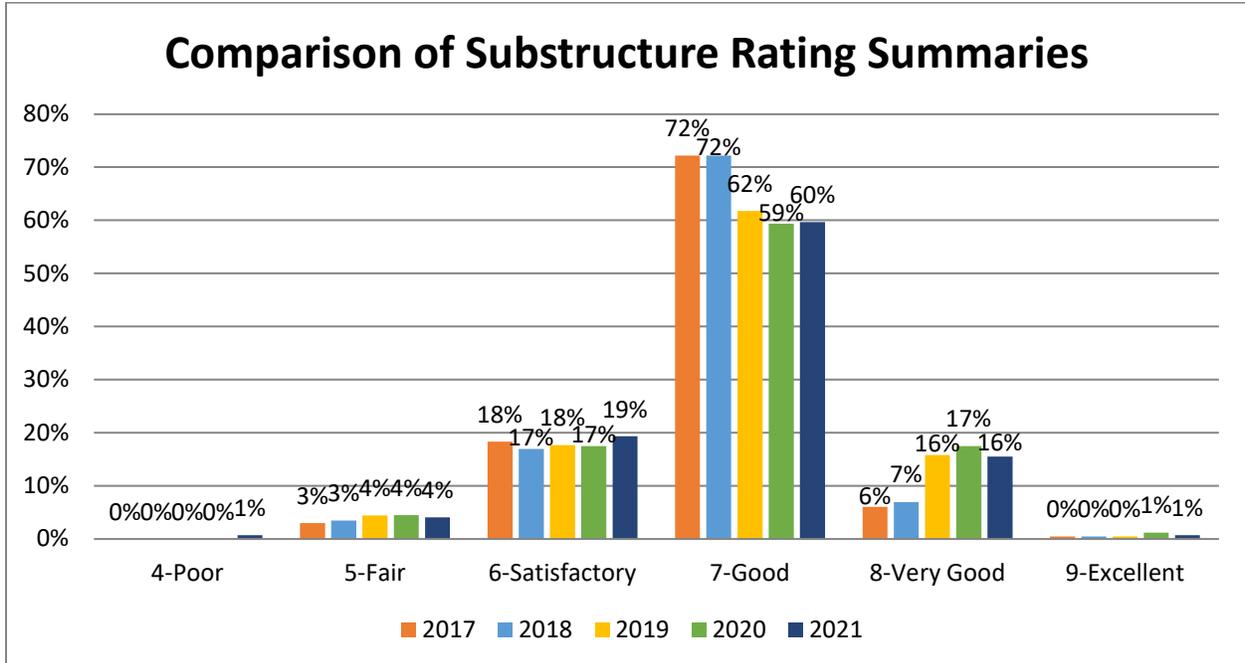
Figure 2.3.5 – Graph showing distribution of Substructure summary ratings for bridges maintained by the OTIC as viewed on the Assetwise inspection form from 2017-2021. (Note due to rounding for clarity total may not equal 100% in some years)

In general, a below satisfactory summary rating does not indicate a condition that is unsafe for either of these elements. However, based on the distribution of ratings, the OTIC should consider developing a substructure preventative maintenance and repair plan aimed to extend the usable life of these critical infrastructure elements as well.

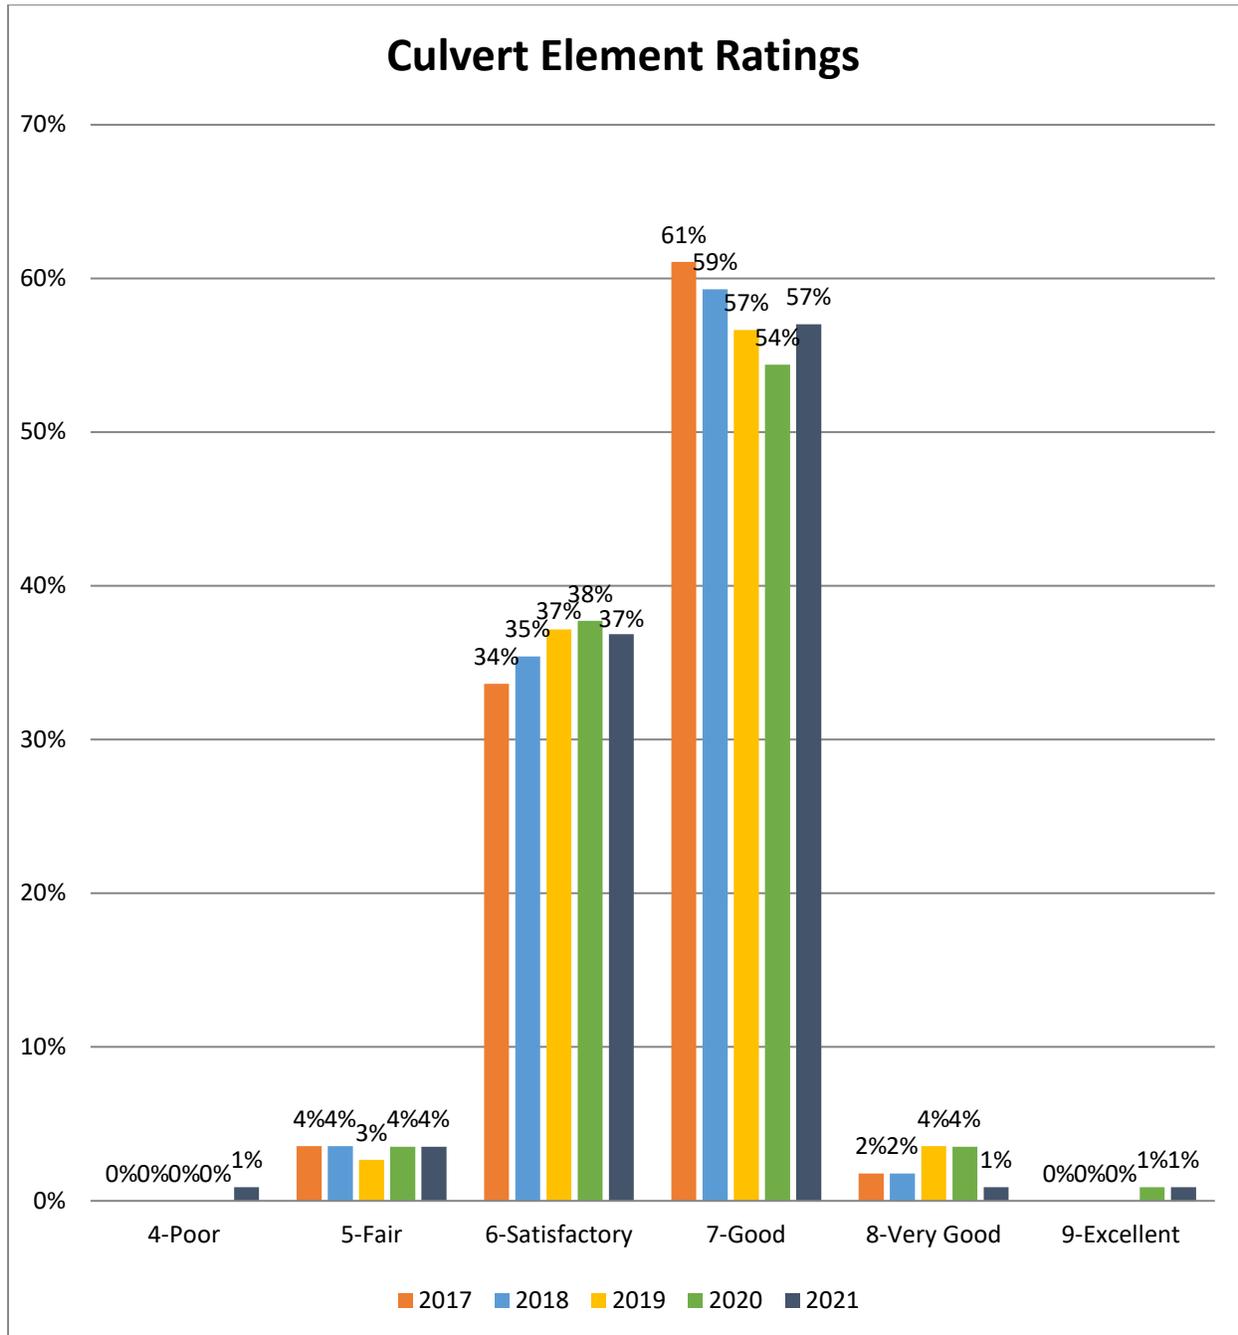
Structures having a clear span of ten (10) feet or greater are inspected and reported as bridges per Ohio Revised Code Section 5501.74 (Federal definition is twenty (20) feet or greater). There are currently 114 culverts that are owned and maintained by the OTIC which fall into the category of spans ten (10) feet and greater (thus classified as a bridge). The majority of these culverts are cast-in-place reinforced concrete box shapes with single or multiple cells. The most common deficiencies include deteriorated headwalls and wingwalls and obstruction and scour of the waterways. **Figure 2.4.1** shows a summary of the element level ratings for culverts (classified as bridges) maintained by the OTIC for 2017 through 2021.

Figure 2.4.1 – Graph showing element ratings for culverts maintained by the OTIC as viewed on the Assetwise inspection form for 2017-2021 (Note due to rounding for clarity total may not equal 100% in some years)
