**OHIO TURNPIKE AND  
INFRASTRUCTURE  
COMMISSION  
68<sup>th</sup> Annual Consulting  
Engineer Inspection Report**

## **Sixty-Eighth Annual Consulting Engineer Inspection Report**

The Ohio Turnpike and Infrastructure Commission  
682 Prospect Street  
Berea, Ohio 44017

AECOM Technical Services, Inc.  
564 White Pond Drive  
Akron, Ohio 44320-1100

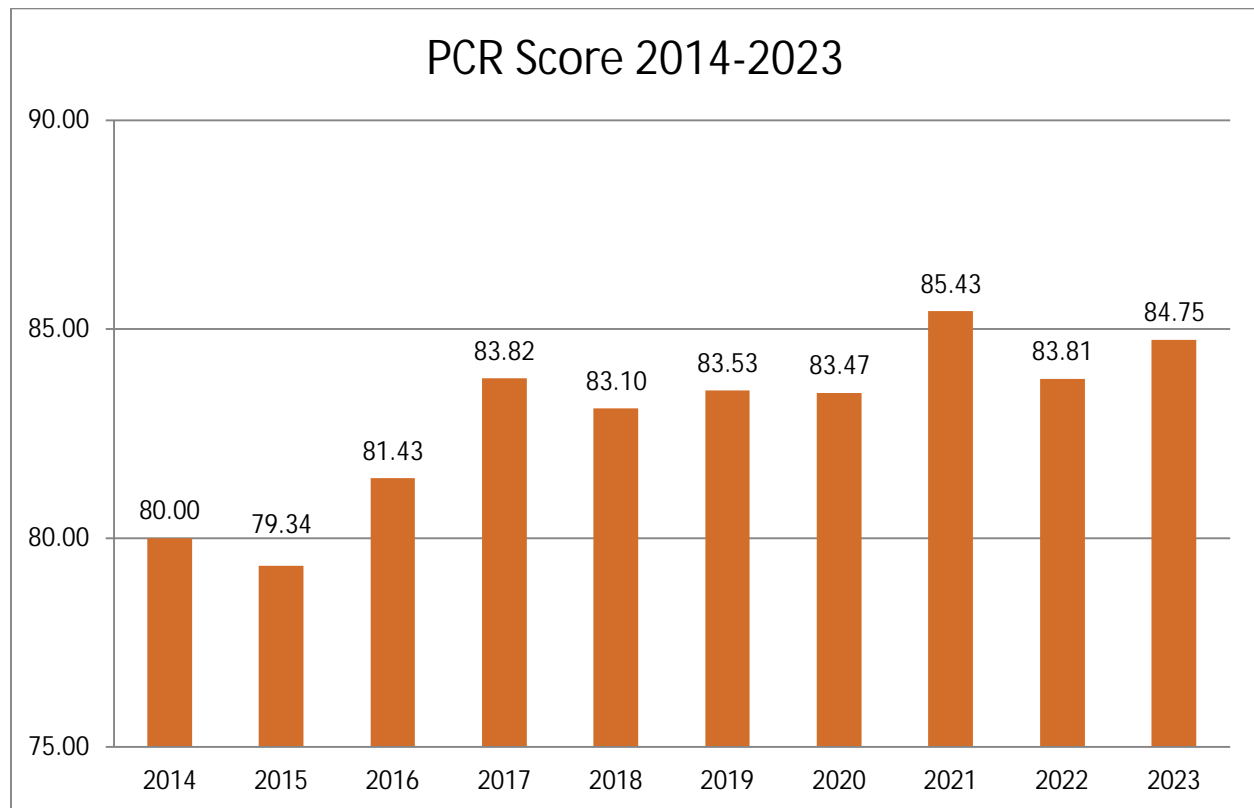
Overall, the mainline travel lanes on the Turnpike continue to be very well maintained, earning an average Pavement Condition Rating (PCR) score of 84.75/100 in 2023, increasing from 83.81/100 in 2022. Based on the Turnpike's continued investment in pavement improvements PCR ratings are expected to remain the same or improve in the future. The shoulders are also well maintained with an average rating of "GOOD" per the ODOT pavement condition rating criteria. Deductions in the shoulder score were primarily due to rough pavement, spalling and shifting of pavement and scattered areas of erosion. The current Resurfacing and Pavement Replacement Programs continue to prove effective, providing a consistent and reliable driving experience throughout the full length of the Turnpike. It is recommended that the OTIC continue the Resurfacing and Pavement Replacement Programs as detailed in the current 50-year Capital Master Plan. **Figure 2.1.1** shows the changes in these scores by percentage over time.

Figure 2.1.1 – Changes in Pavement Condition Rating Scores from 2014-2023

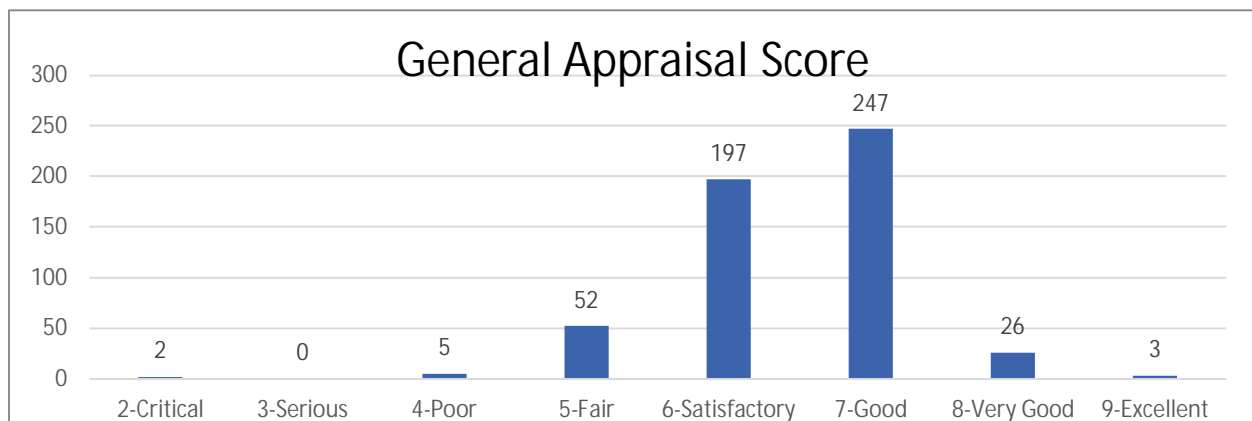
Based on the bridge condition inspections performed in 2023, the large majority of bridges maintained by the OTIC are in Satisfactory to Excellent Condition (NBIS Scores 6-9) according to National Bridge Inspection Standards (NBIS). Per ODOT and OTIC policy the total number of bridges maintained by OTIC is 532 (417 bridges plus 115 culverts classified as bridges). Out of a total of 532 bridges, only 11.1% of the structures (59 total, 50 bridges plus 9 culverts classified as bridges) rate below Satisfactory Condition (**Figure 2.3.1**) and the majority of deficiencies at these structures is related to superstructure (beam) section loss. The total number rated below Satisfactory is up 1% from 2022. Of the superstructure deficiencies, the most downgraded element impacting the overall structure rating was found to be section loss in the lower webs and bottom flanges of bridges spanning over the Turnpike mainline. Some of these ratings are due to active corrosion and others have had their beams cleaned and painted but still have enough section loss to warrant a Fair rating. The beams rated Fair do not currently pose a safety hazard to the public; however, continued deterioration has the potential to increase maintenance and repair costs as well as decrease the overall service life of the structures. Rehabilitation should be performed at these structures in the near future and the deficient elements should be monitored closely until repairs can be made. **Figure 2.3.2** shows the changes in these scores by percentage of inventory over time.

*Figure 2.3.1 – Graph showing distribution of overall NBIS Condition Ratings for bridges maintained by the OTIC. NBIS Scoring criteria based on 0-9 evaluation with 0 being Failed and 9 being Excellent. Ratings of 5 or greater indicate structural elements may or may not show deterioration but remain sound with no significant affects to the load path capacity. For additional information see ODOT MBI 2014 Table 34.*

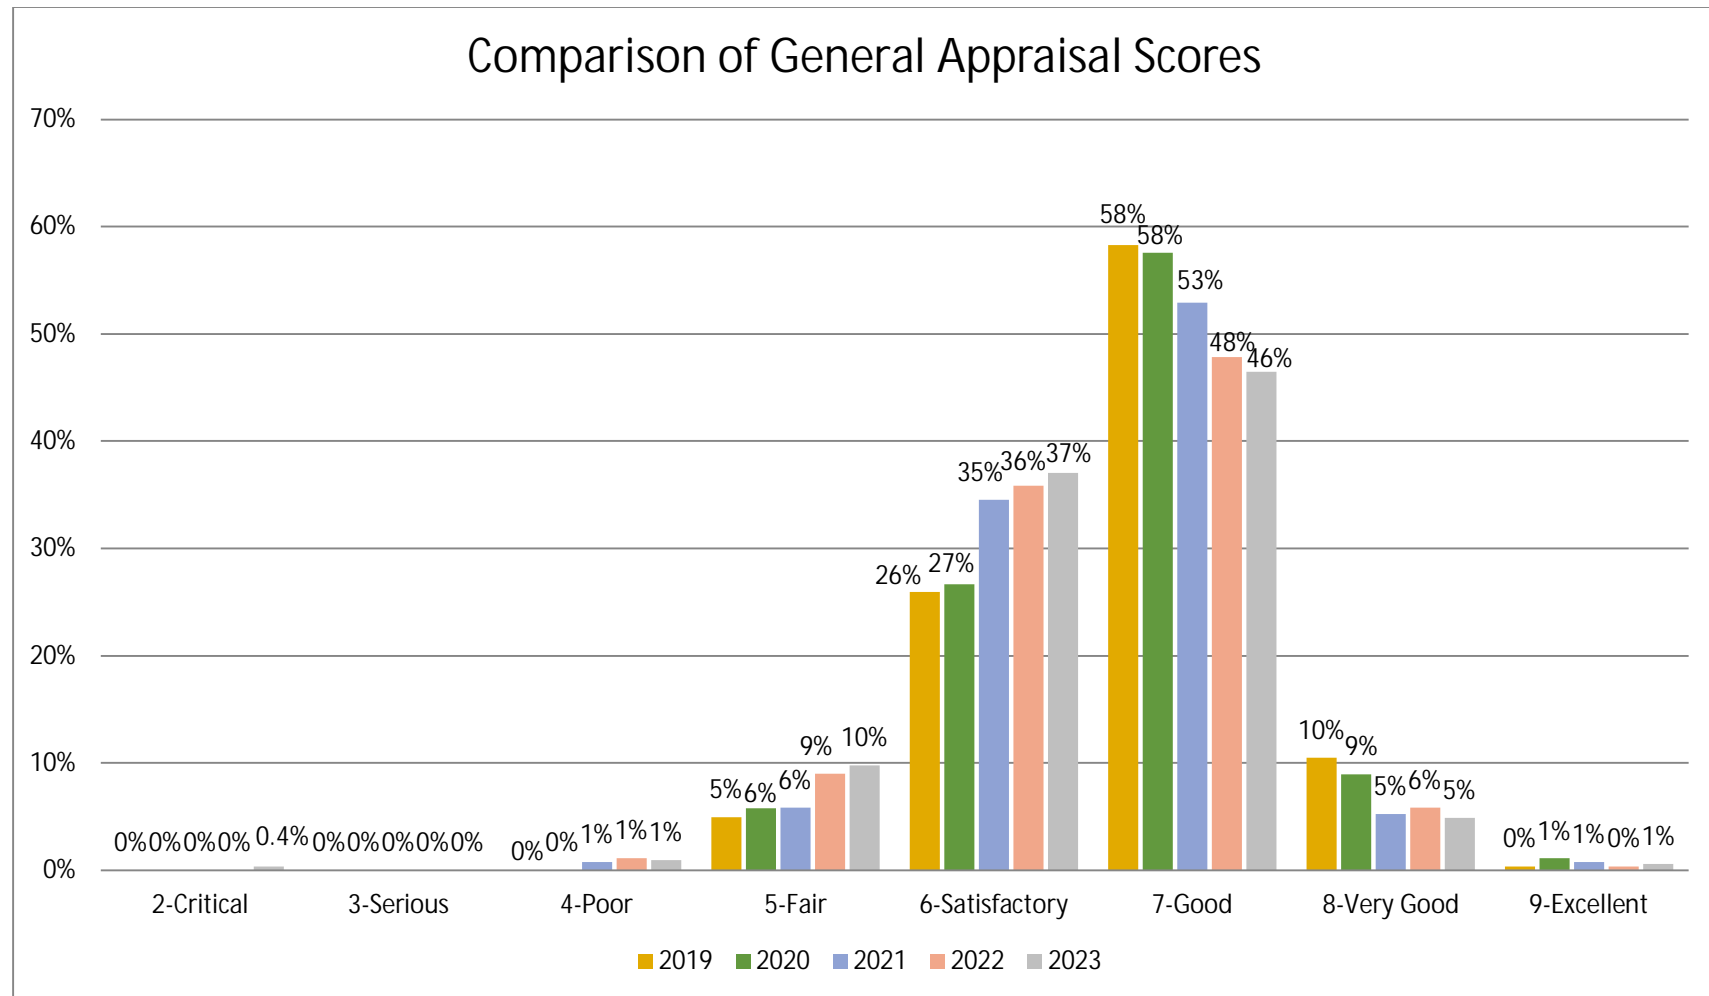
Figure 2.3.2 – Graph showing distribution of General Appraisal ratings for bridges maintained by the OTIC from 2019-2023. (Note due to rounding and for clarity total may not equal 100% in some years)

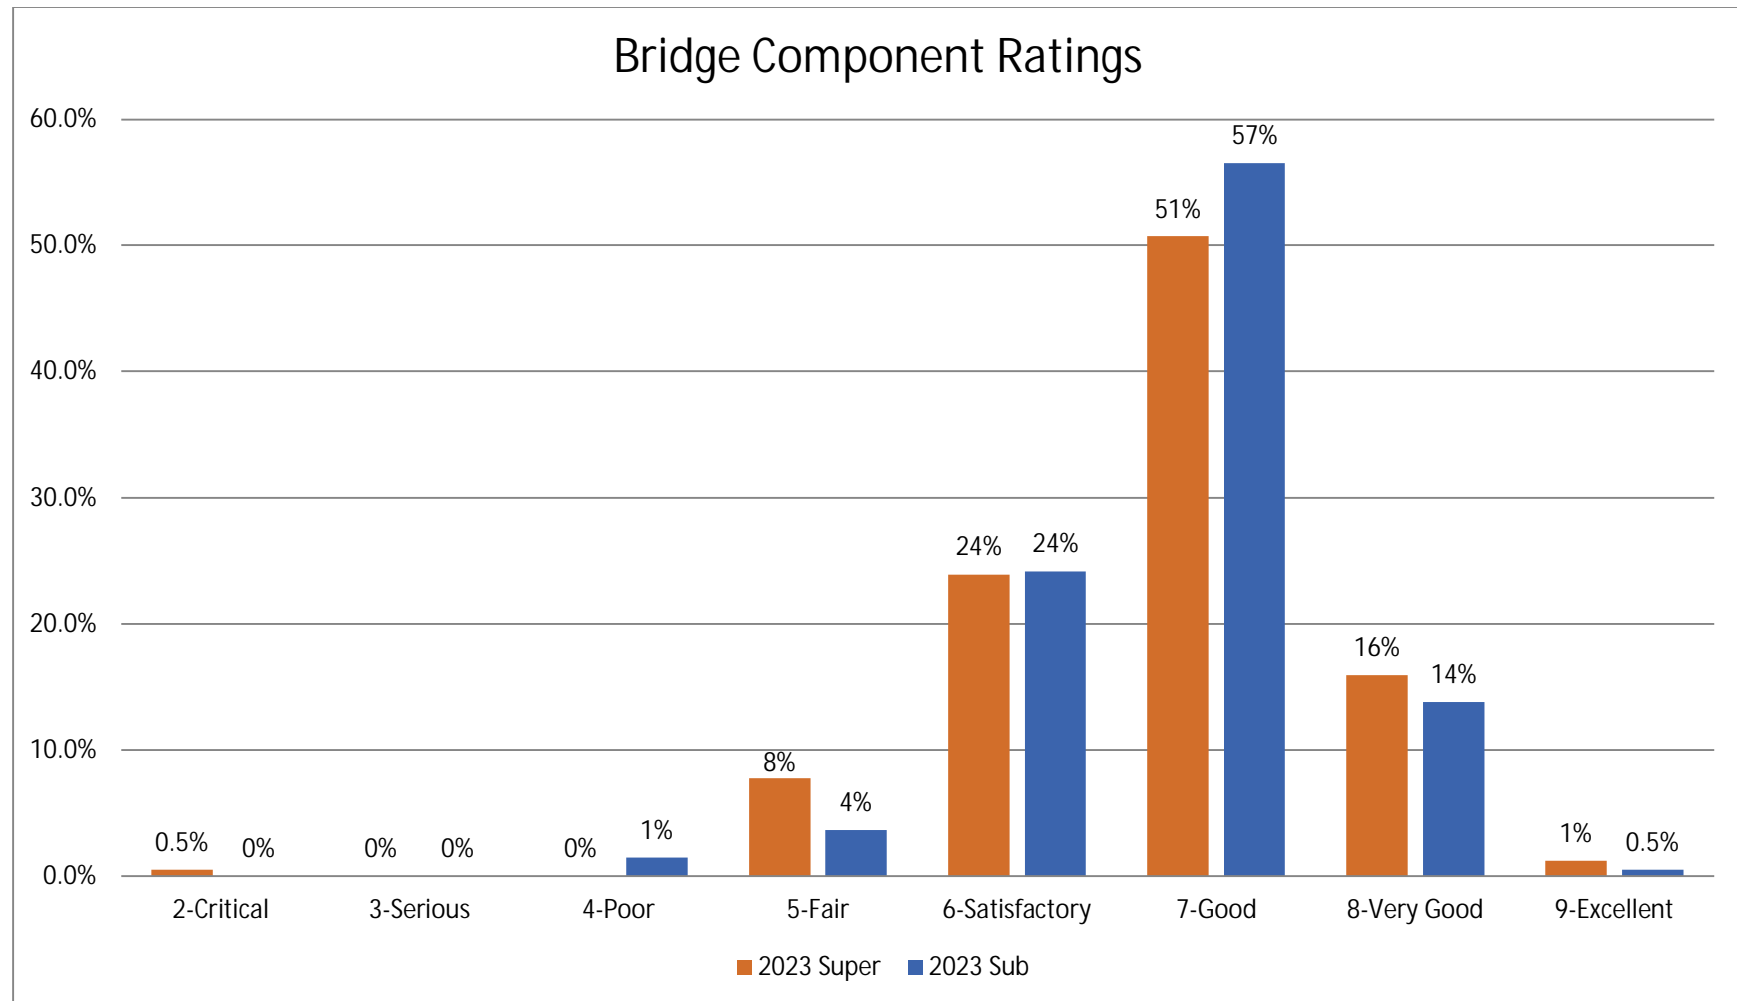
Figure 2.3.3 – Graph showing distribution of Superstructure and Substructure summary ratings for bridges maintained by the OTIC. (Note due to rounding for clarity total may not equal 100%)

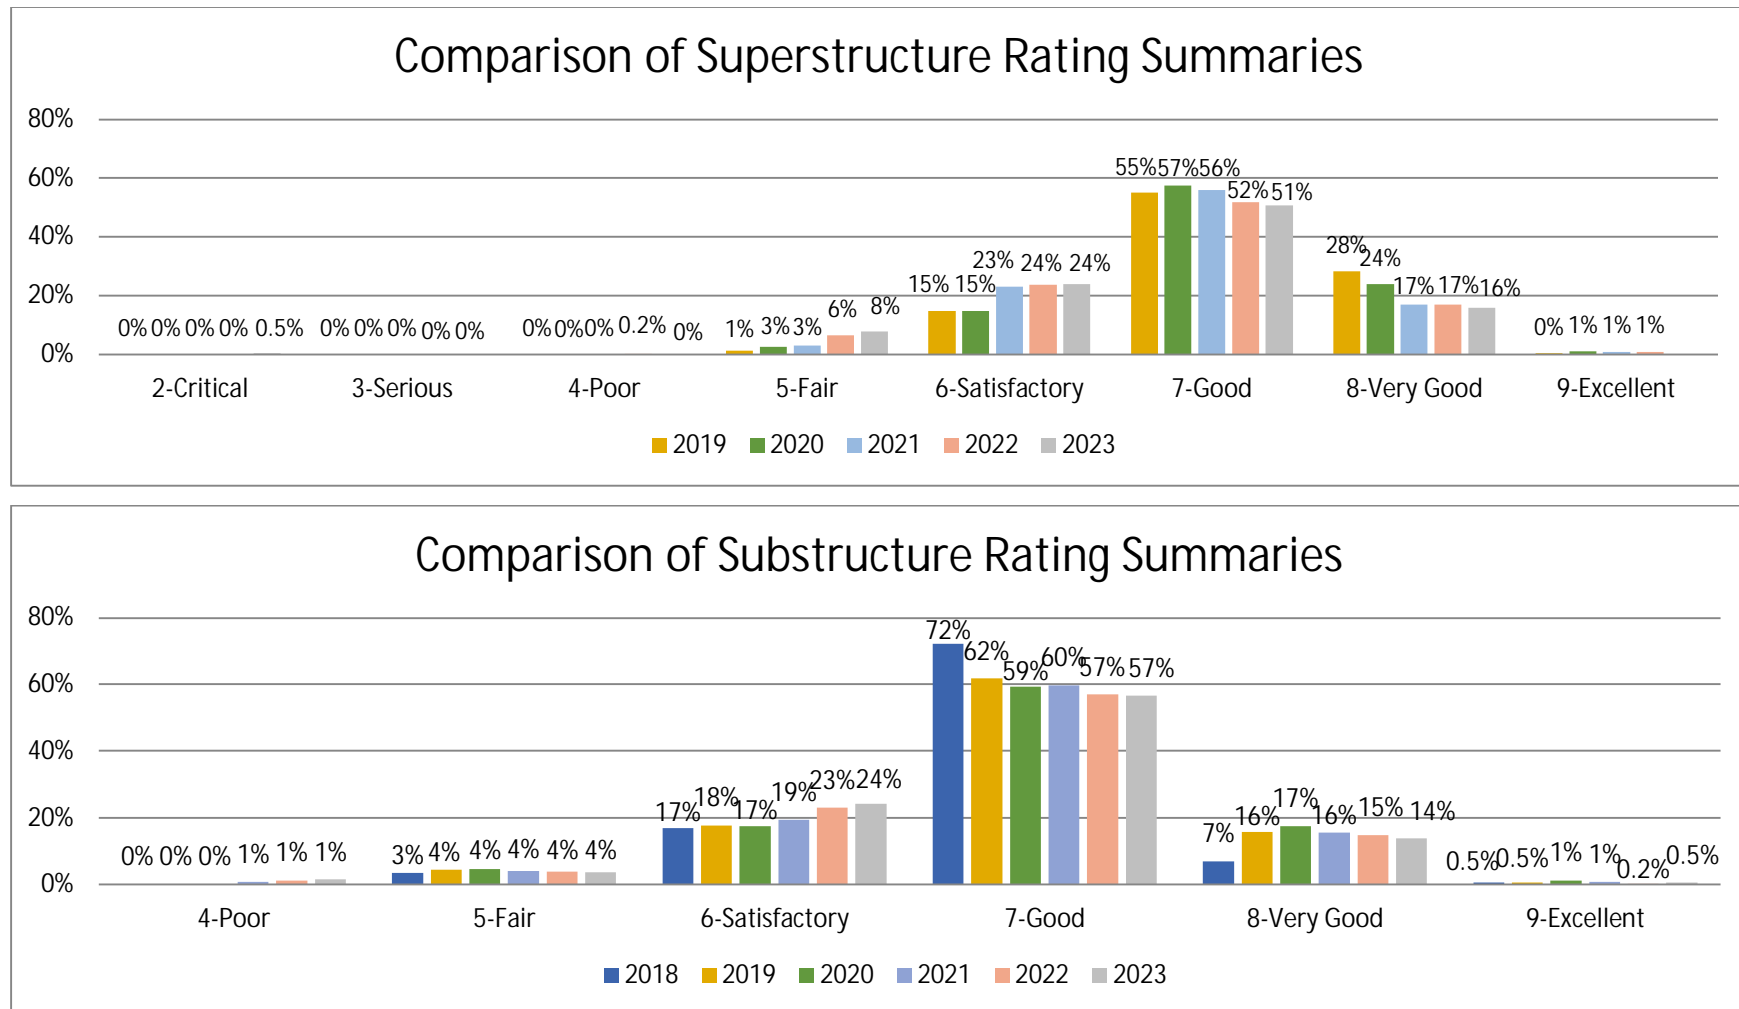
Figure 2.3.4 – Graphs showing distribution of Superstructure and Substructure summary ratings for bridges maintained by the OTIC from 2019-2023. (Note due to rounding for clarity total may not equal 100% in some years)

In general, a below satisfactory summary rating does not indicate a condition that is unsafe for either of these elements. However, based on the distribution of ratings, the OTIC should consider developing a preventative maintenance and repair plan aimed to extend the usable life of these critical infrastructure elements as well.

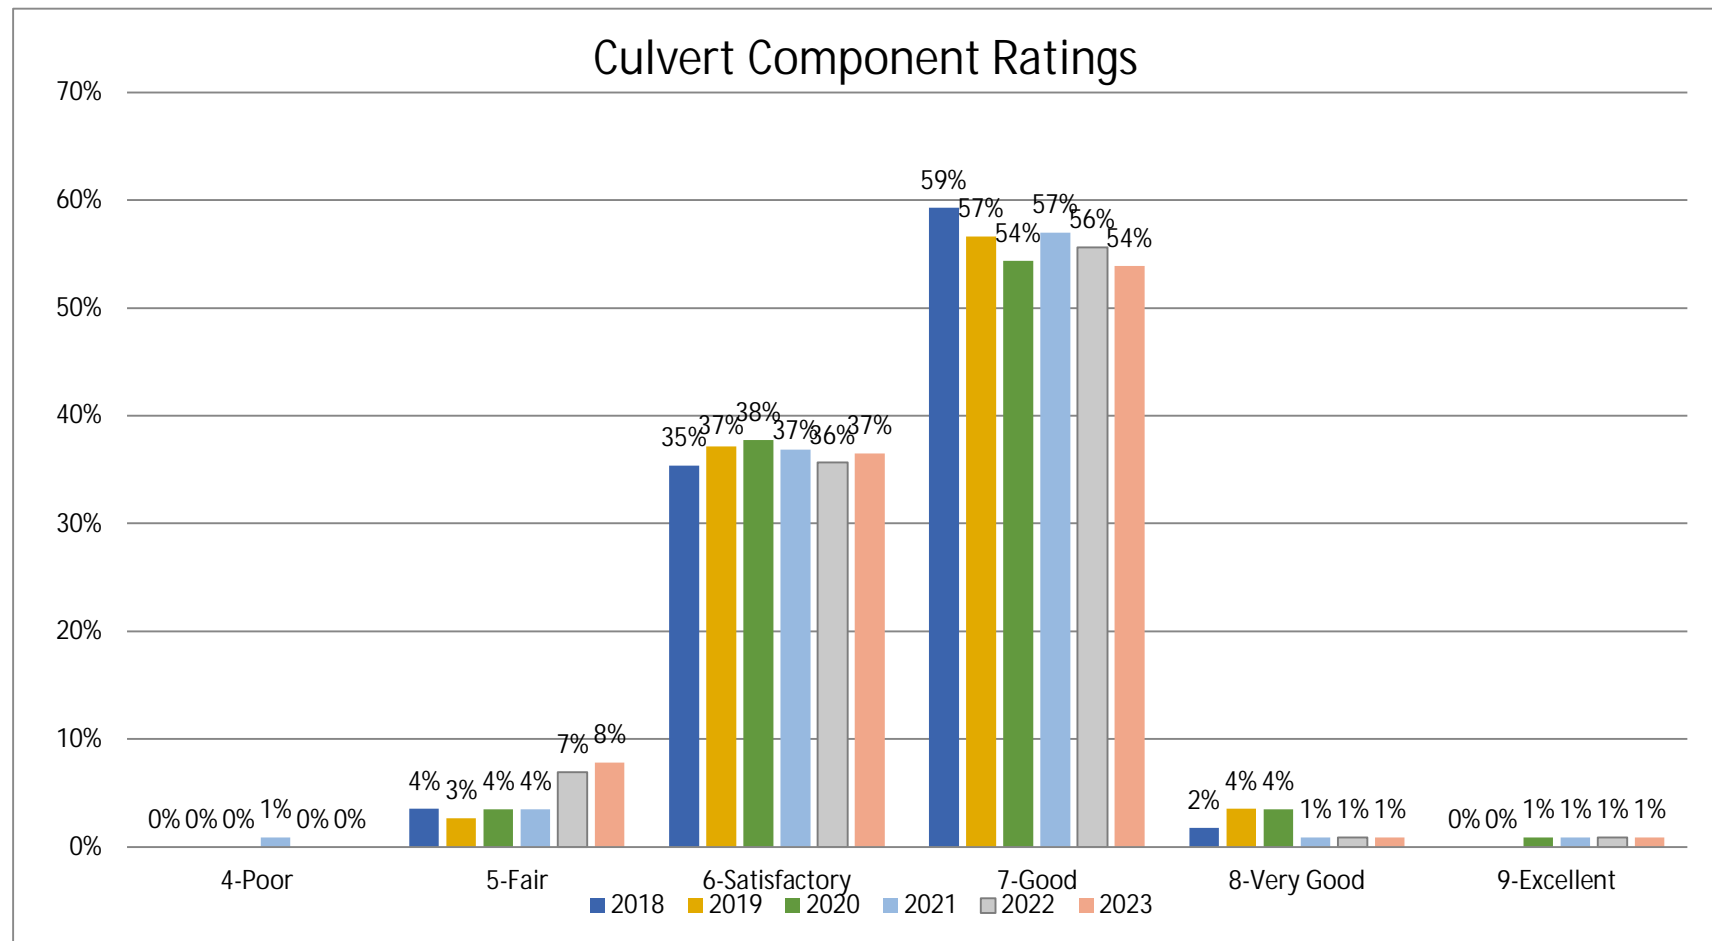
Structures having a clear span of ten (10) feet or greater are inspected and reported as bridges per Ohio Revised Code Section 5501.74 (Federal definition is twenty (20) feet or greater). There are currently 115 culverts that are owned and maintained by the OTIC which fall into the category of spans ten (10) feet and greater (thus classified as a bridge). The majority of these culverts are cast-in-place reinforced concrete box shapes with single or multiple cells. The most common deficiencies include deteriorated headwalls and wingwalls and obstruction and scour of the waterways. **Figure 2.4.1** shows a summary of the element level ratings for culverts (classified as bridges) maintained by the OTIC for 2018 through 2023.

Figure 2.4.1 – Graph showing element ratings for culverts maintained by the OTIC from 2018-2023 (Note due to rounding for clarity total may not equal 100% in some years)
