### OHIO TURNPIKE AND INFRASTRUCTURE COMMISSION

### ADDENDUM NO. 1 ISSUED: SEPTEMBER 1, 2023

### REQUEST FOR LETTERS OF INTEREST (LOIs) FOR PROFESSIONAL ENGINEERING SERVICES PROJECT NO. 71-23-09

## **PHYSICAL CONDITION REPORT** 2019 IN-DEPTH INSPECTION OF OHIO TURNPIKE BRIDGES OVER THE MAUMEE RIVER

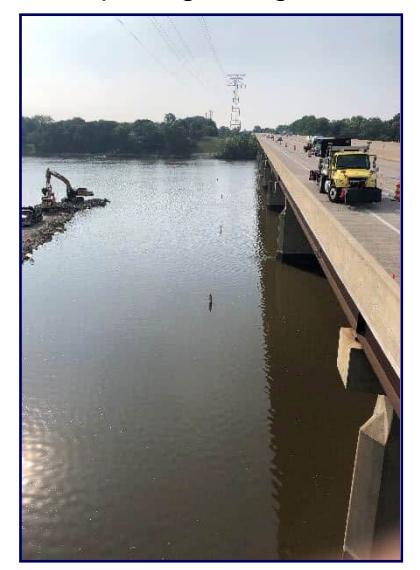
The hydraulic opening is in good condition with no significant deficiencies noted.

Photo 32: North bridge elevation.

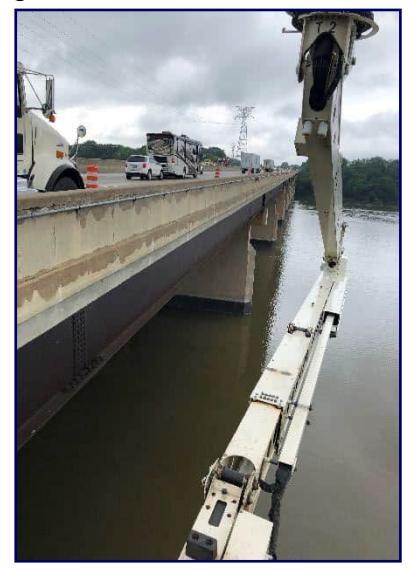
Photo 33: South bridge elevation.

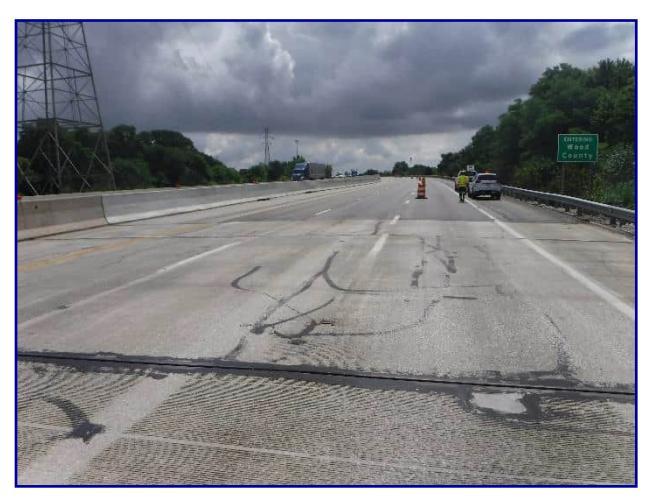
The embankments are in good condition with no significant deficiencies noted.

Photo 34: Westbound east approach.

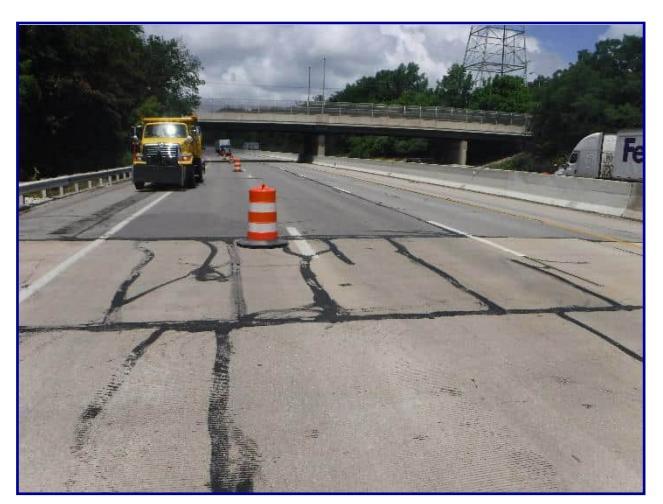
Photo 35: Eastbound west approach.

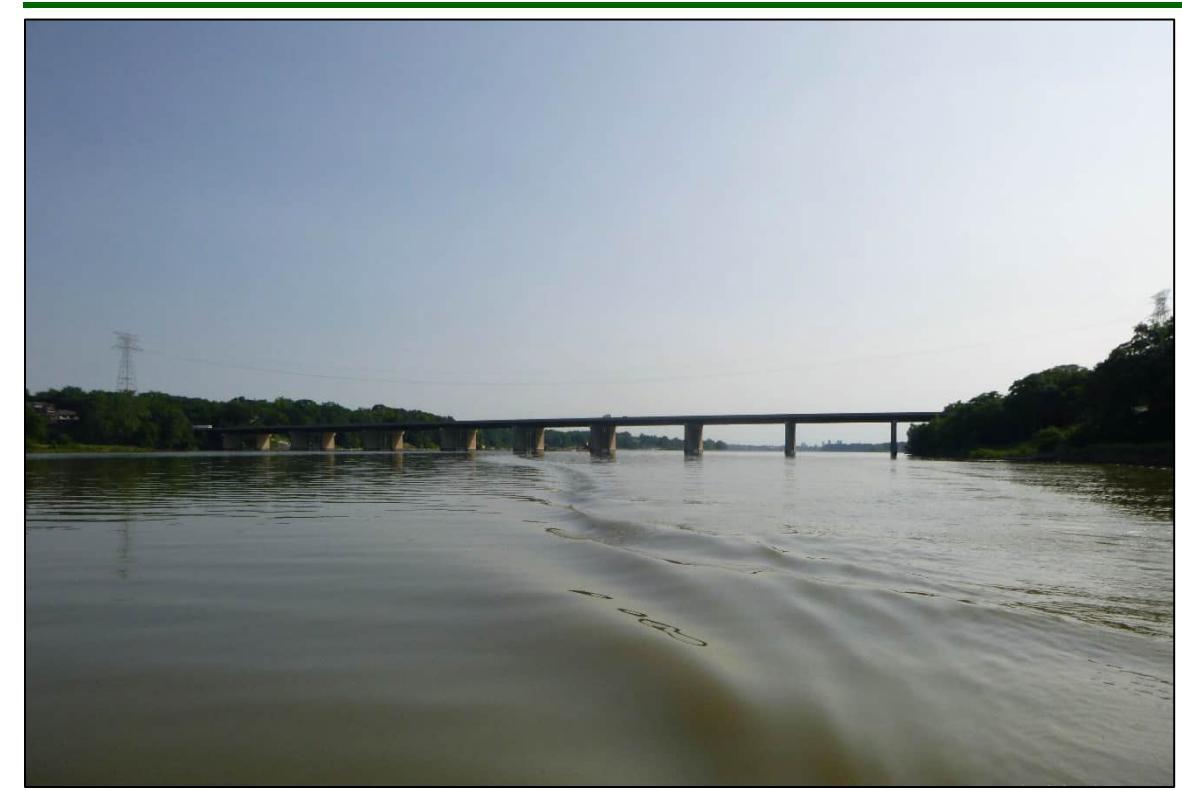
Photograph No. 1: Overall View of Structure No. 4829956 EB / 4829964 WB, Looking North.

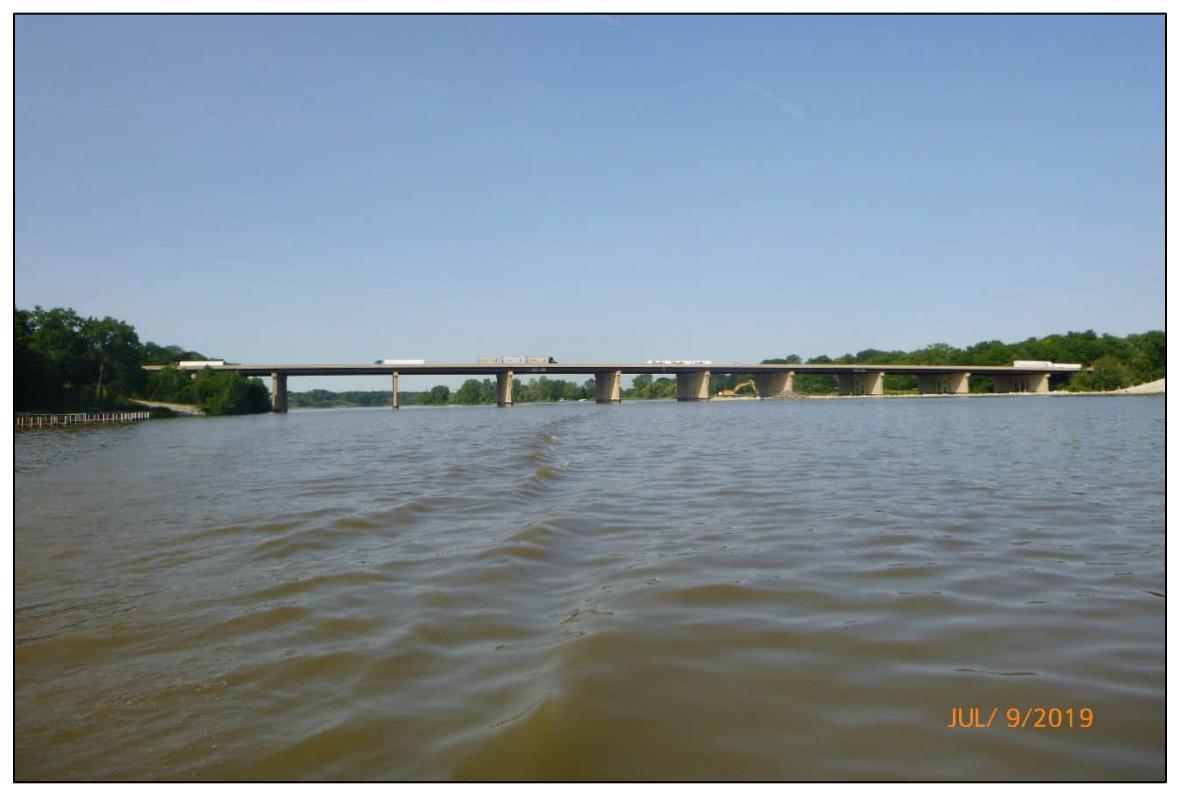
Photograph No. 2: Overall View of Structure No. 4829956 EB / 4829964 WB, Looking South.

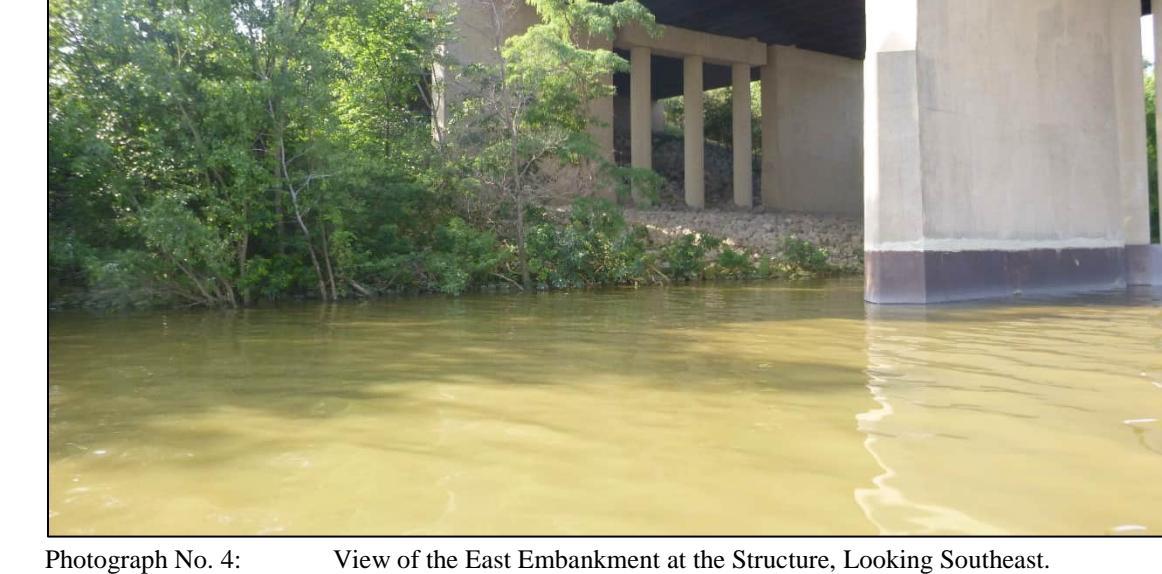
At the time of the inspection, the waterline of the Maumee River was located approximately 4.2 ft below the top of webwall along the bridge centerline on the west face of Pier 2, which corresponds to an assumed waterline elevation of 95.8 ft. During the inspection, the waterway was flowing at approximately 1 ft per second. The bridge pier skew was consistent with the channel alignment and does not require attention at this time. The east and west shorelines were heavily vegetated, well protected, and moderately to steeply sloped with no signs of erosion. Refer to Photographs 3 through 8 in Exhibit 2 for views of the shorelines near the structure.

Photograph No. 3: View of the East Embankment Upstream of the Structure, Looking Northeast.

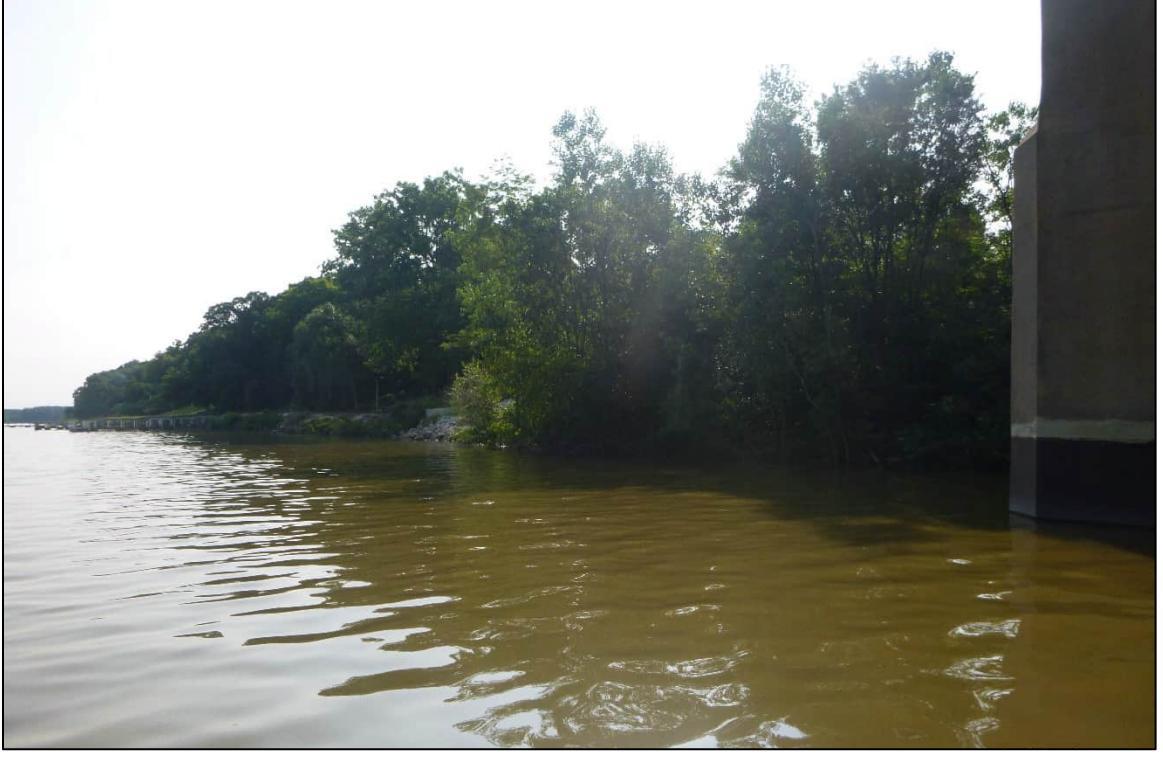
Photograph No. 5: View of the East Embankment Downstream of the Structure, Looking Northeast.
